RE: Everett House Community Healing Center – Transportation Analysis Letter

We have completed our transportation analysis of your existing conditional use facility at 2917 and 2927 SE Everett Street and 2926 NE Flanders Street in Portland, Oregon. The subject site is the Everett House Community Healing Center, which comprises the three adjacent tax lots and provides community healing and social services in education and wellness programs including services such as healing workshops, neighbors in need programs, teahouse social, relaxation, massage, acupuncture, new thought discussion programs, counselling, domestic violence victims' resources, yoga, chiropractic wellness, spa, and other forms of relaxation and more.

Everett House Community Healing Center

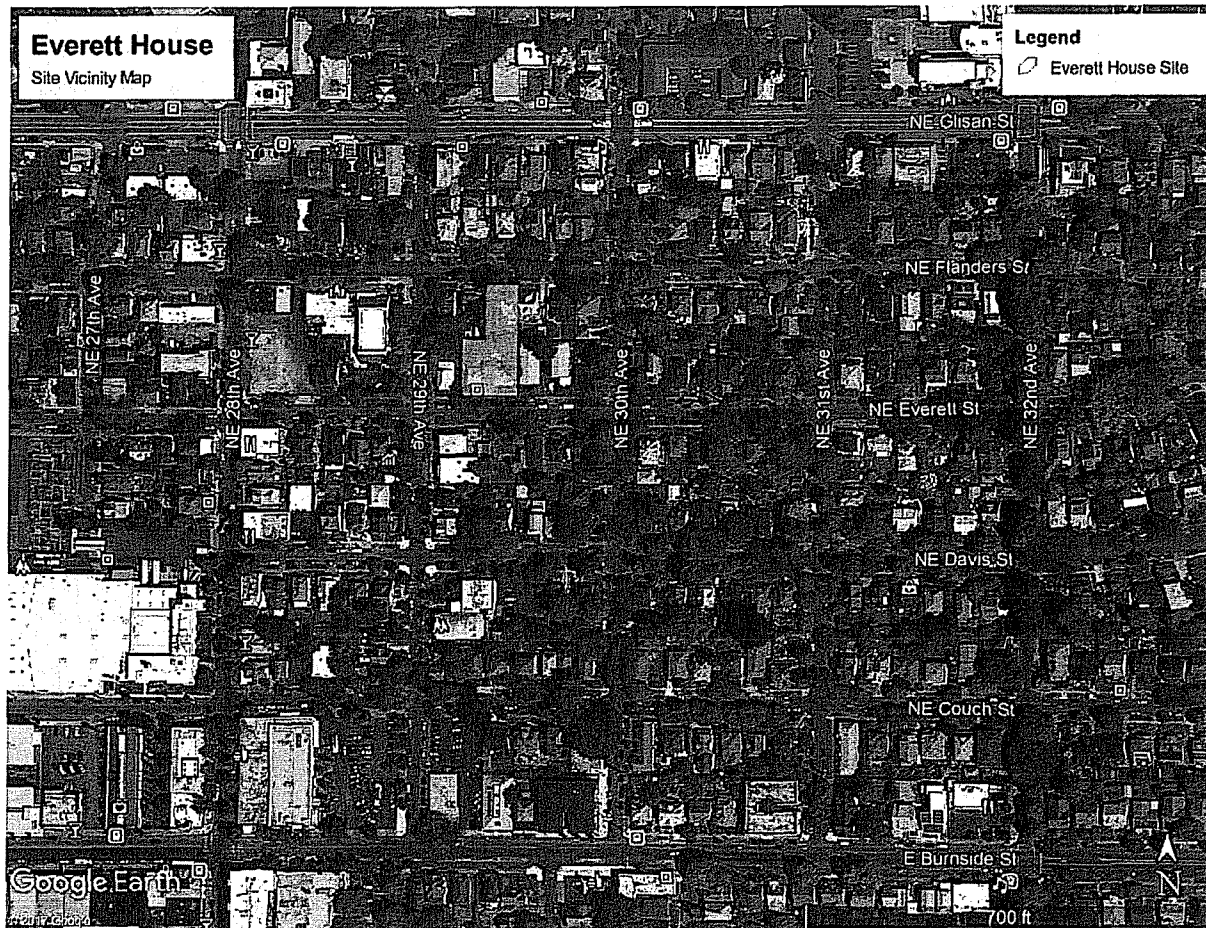
Figure 1 – Site Vicinity Map

An aerial view of the site and nearby vicinity is provided on the following page (Image from Google Earth).

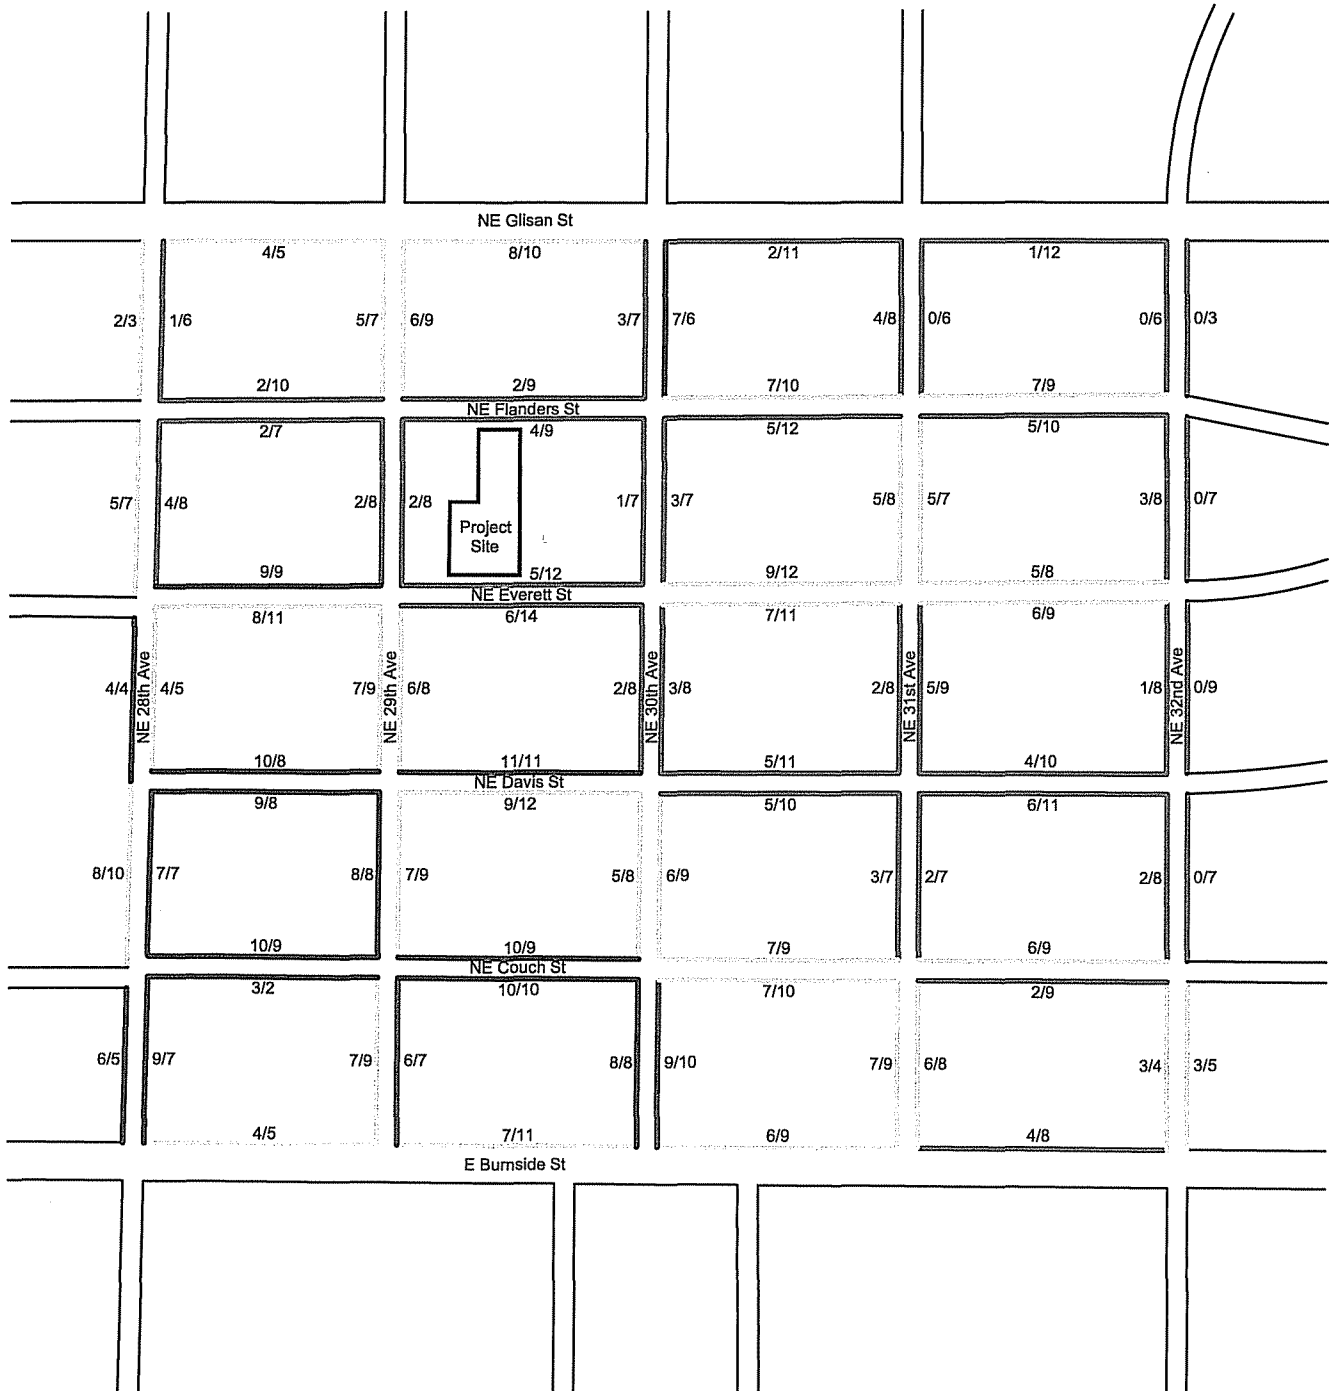
FIGURE
 1

X/Y = "X" OCCUPIED / "Y" AVAILABLE ON-STREET SPACES
 TOTAL OBSERVED PARKING DEMAND = 60% OF CAPACITY

PARKING OCCUPANCY MAP
 Everett House Community Healing Center
 11:00 AM - 12:00 PM (Saturday, December 9, 2017)

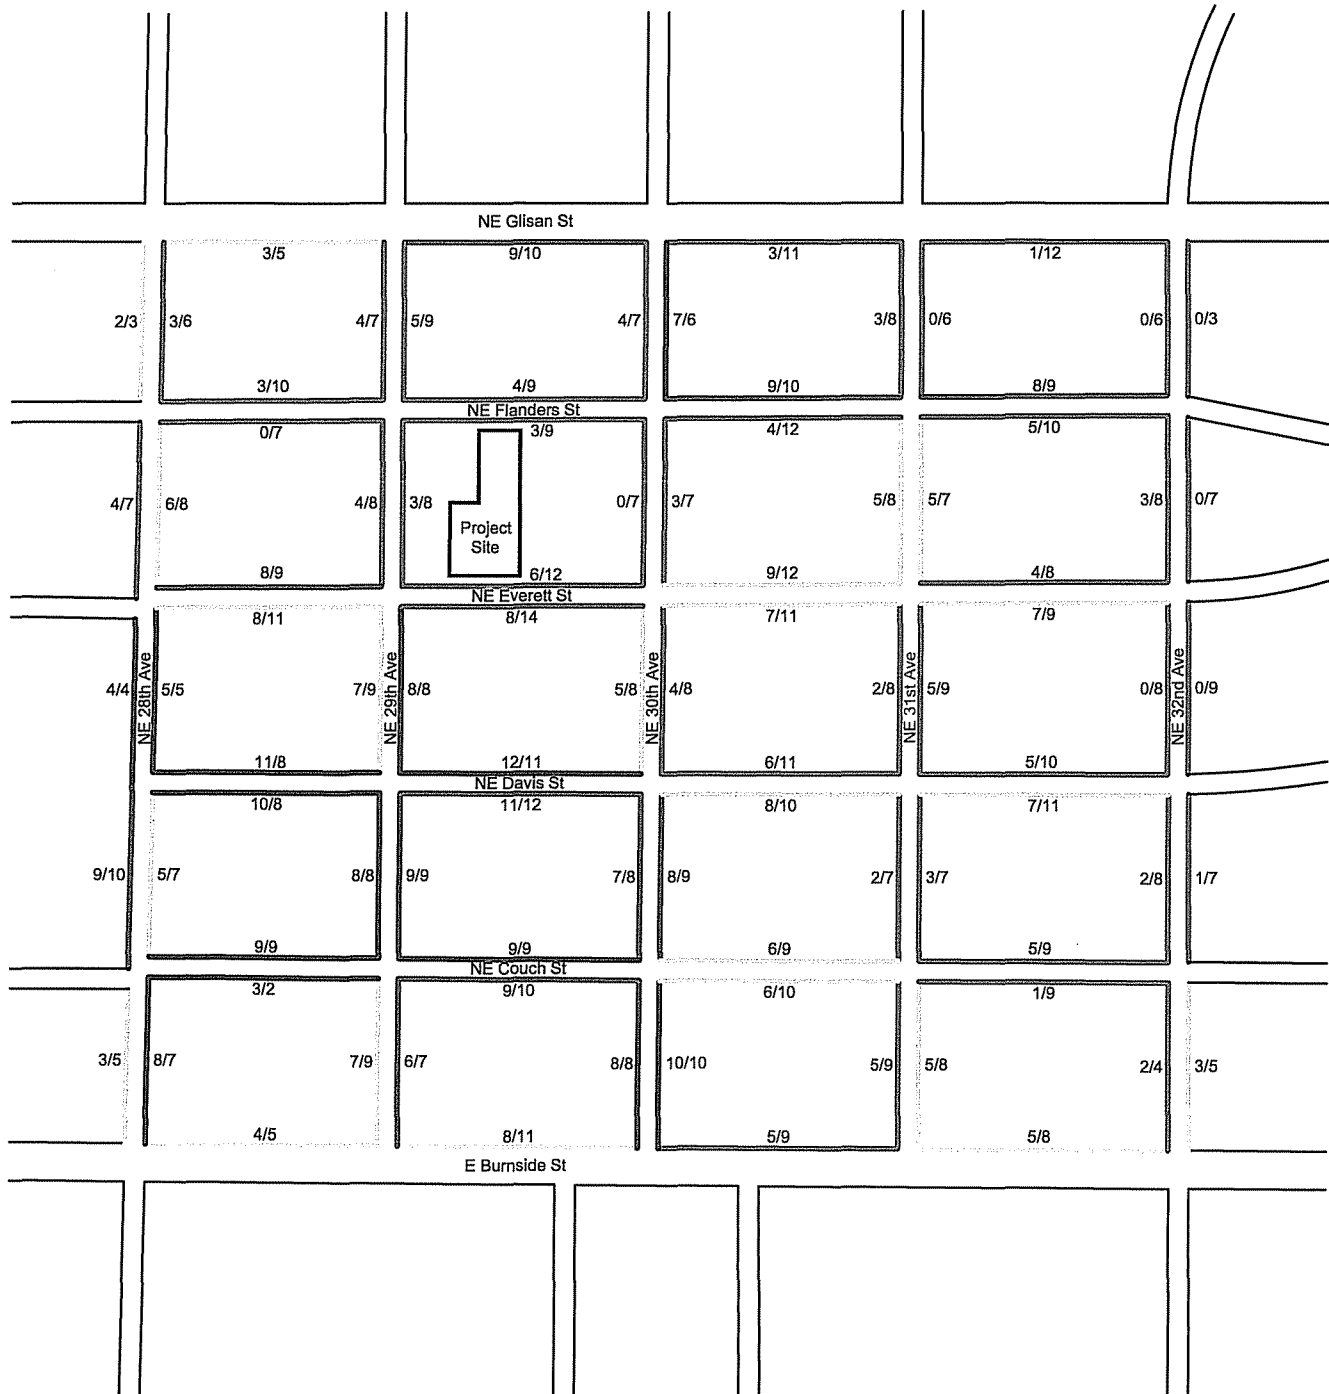
FIGURE
2

X/Y = "X" OCCUPIED / "Y" AVAILABLE ON-STREET SPACES
 TOTAL OBSERVED PARKING DEMAND = 62% OF CAPACITY

PARKING OCCUPANCY MAP
Everett House Community Healing Center
12:00 PM - 1:00 PM (Saturday, December 9, 2017)

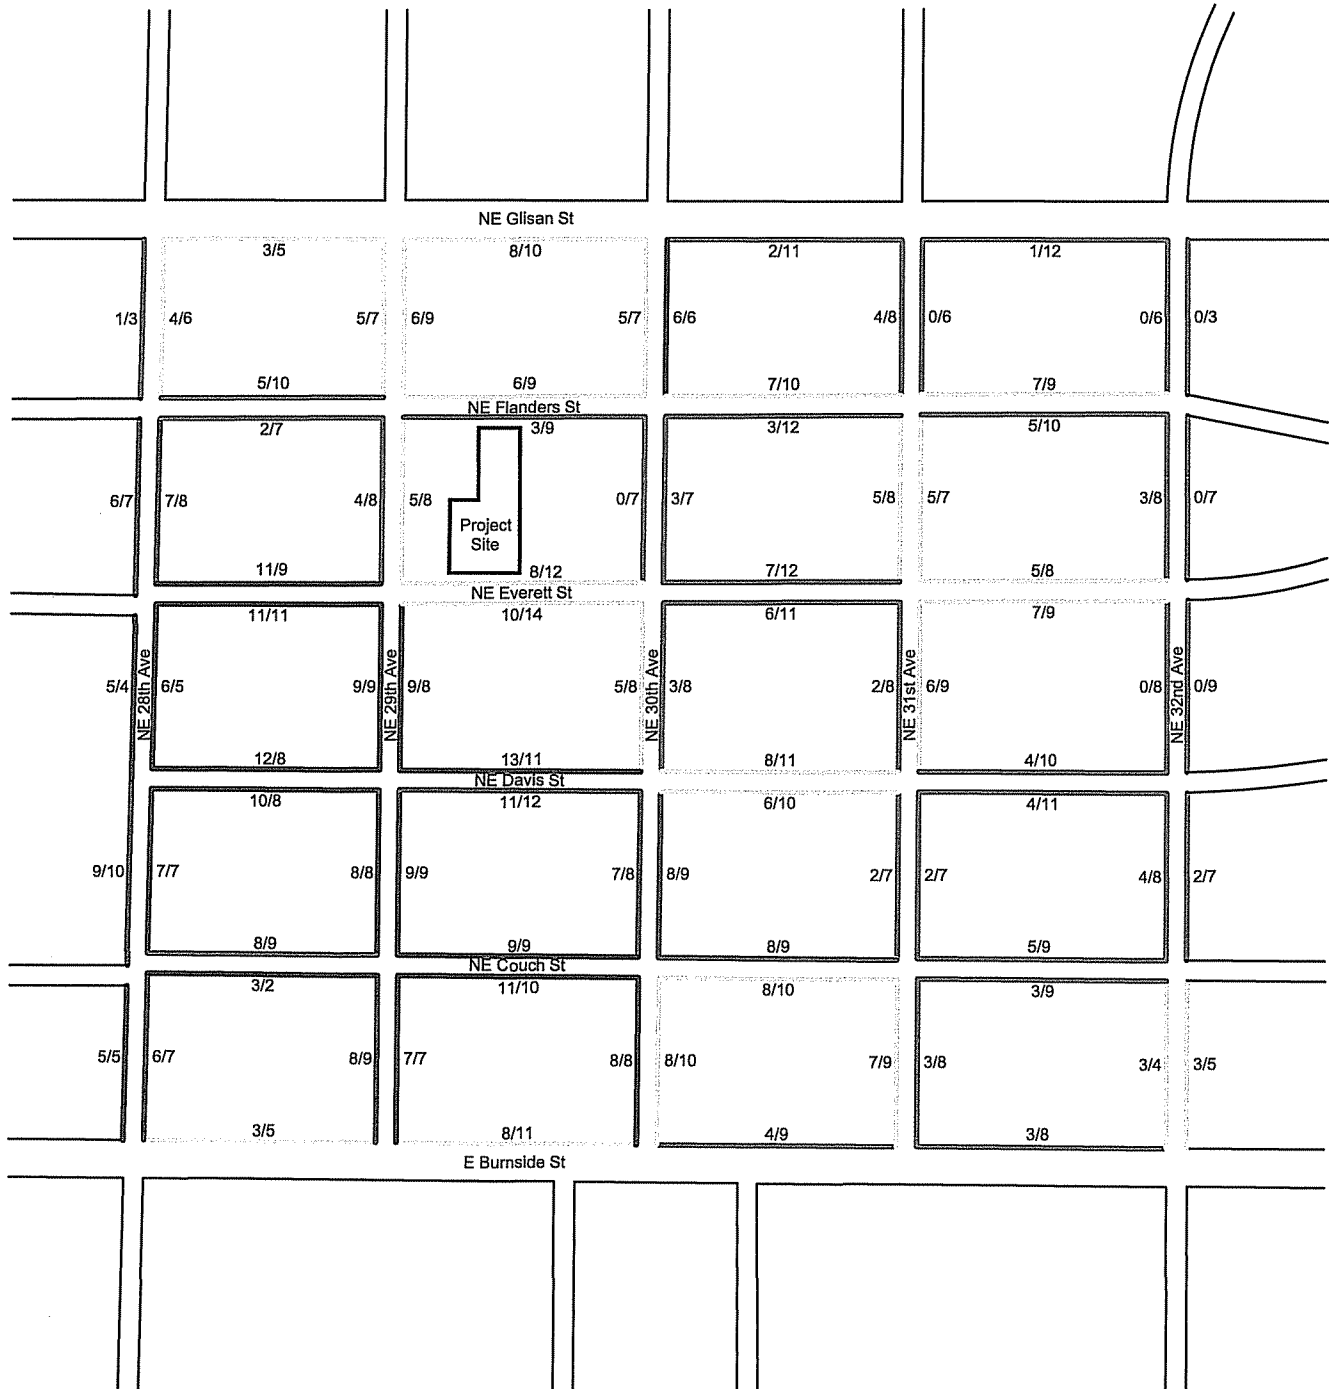
FIGURE
3

X/Y = "X" OCCUPIED / "Y" AVAILABLE ON-STREET SPACES
 TOTAL OBSERVED PARKING DEMAND = 66% OF CAPACITY

PARKING OCCUPANCY MAP
 Everett House Community Healing Center
 1:00 PM - 2:00 PM (Saturday, December 9, 2017)

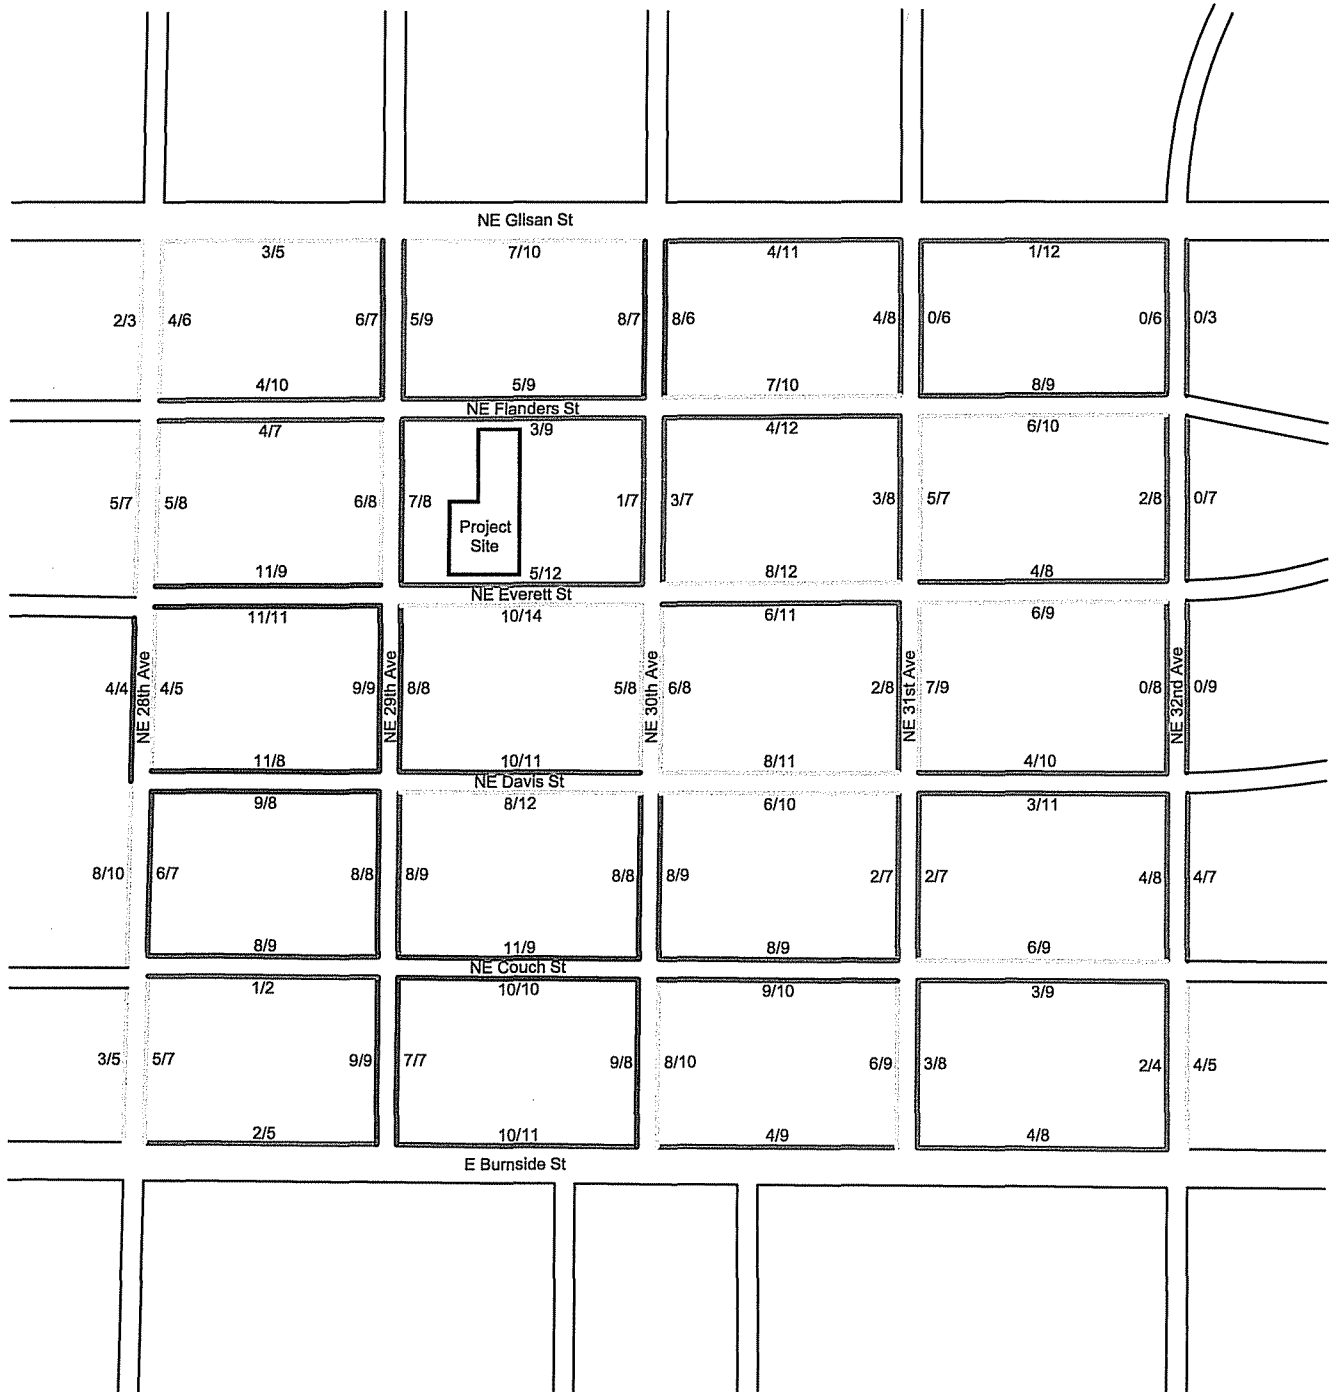
FIGURE
4

X/Y = "X" OCCUPIED / "Y" AVAILABLE ON-STREET SPACES
 TOTAL OBSERVED PARKING DEMAND = 65% OF CAPACITY

PARKING OCCUPANCY MAP
 Everett House Community Healing Center
 2:00 PM - 3:00 PM (Saturday, December 9, 2017)

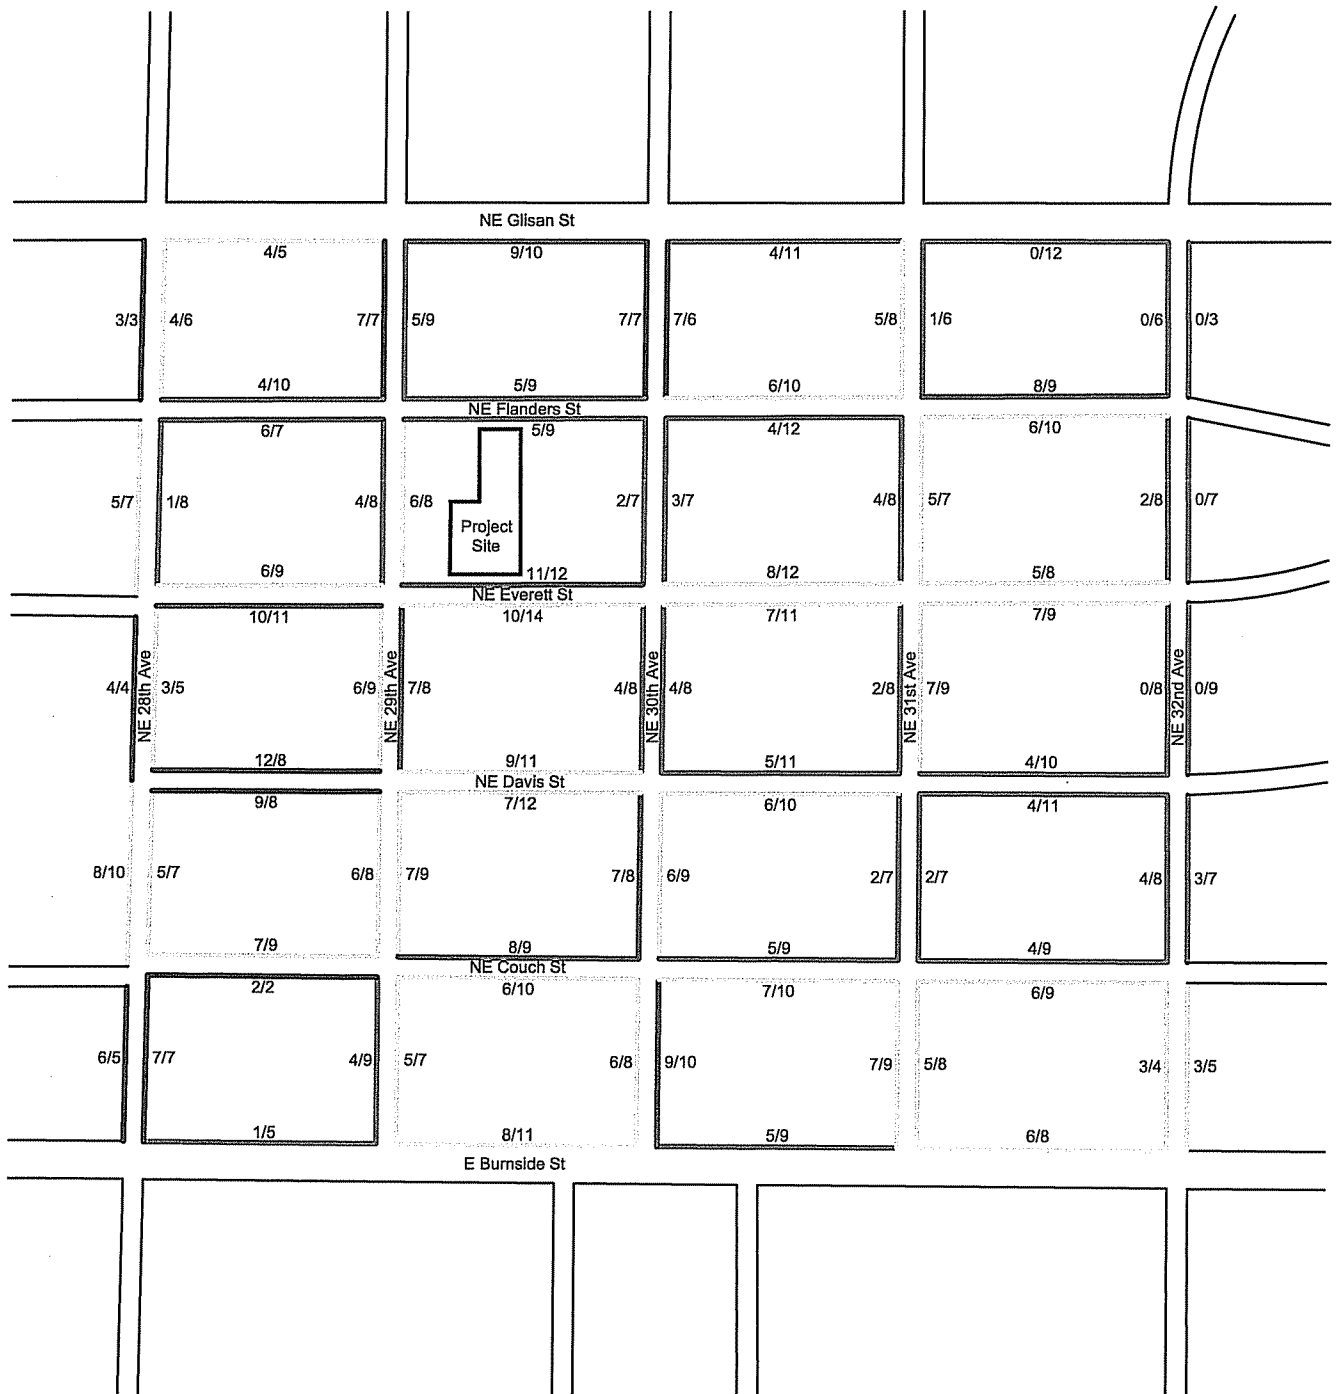
FIGURE
5

X/Y = "X" OCCUPIED / "Y" AVAILABLE ON-STREET SPACES
 TOTAL OBSERVED PARKING DEMAND = 62% OF CAPACITY

PARKING OCCUPANCY MAP
 Everett House Community Healing Center
 3:00 PM -4:00 PM (Saturday, December 9, 2017)

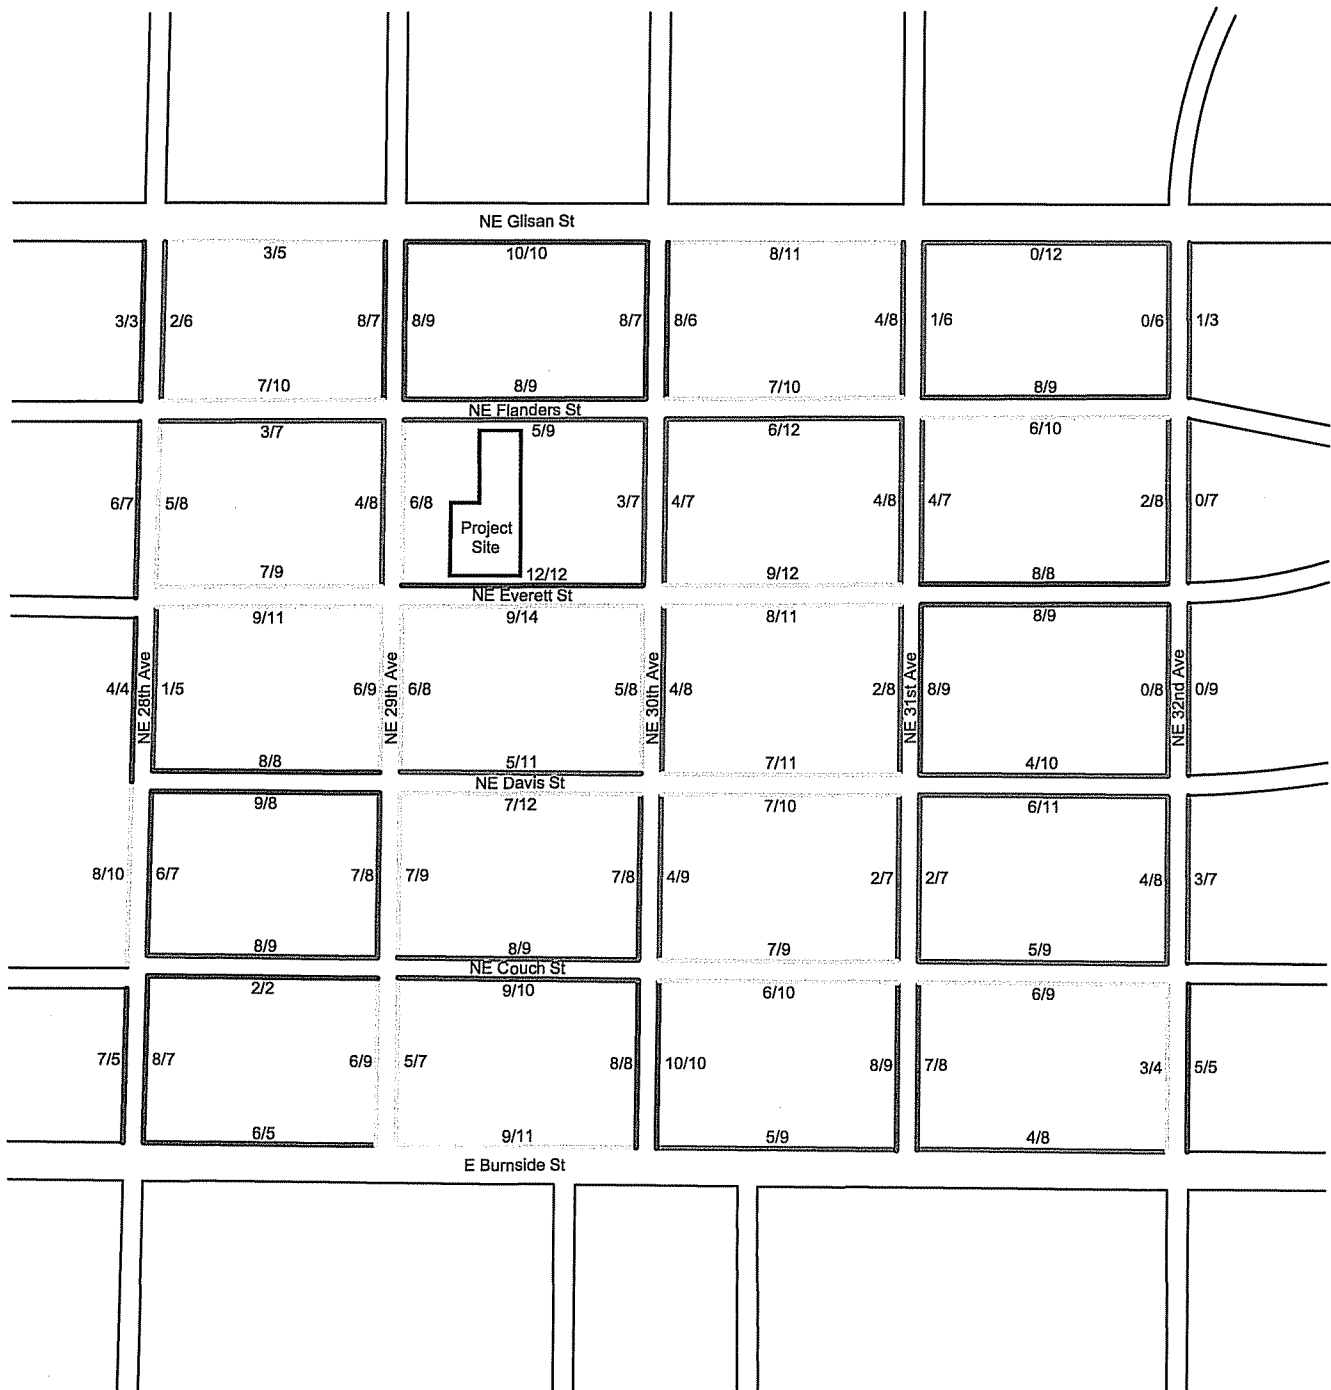
FIGURE
7

X/Y = "X" OCCUPIED / "Y" AVAILABLE ON-STREET SPACES
 TOTAL OBSERVED PARKING DEMAND = 68% OF CAPACITY

PARKING OCCUPANCY MAP
 Everett House Community Healing Center
 5:00 PM - 6:00 PM (Saturday, December 9, 2017)

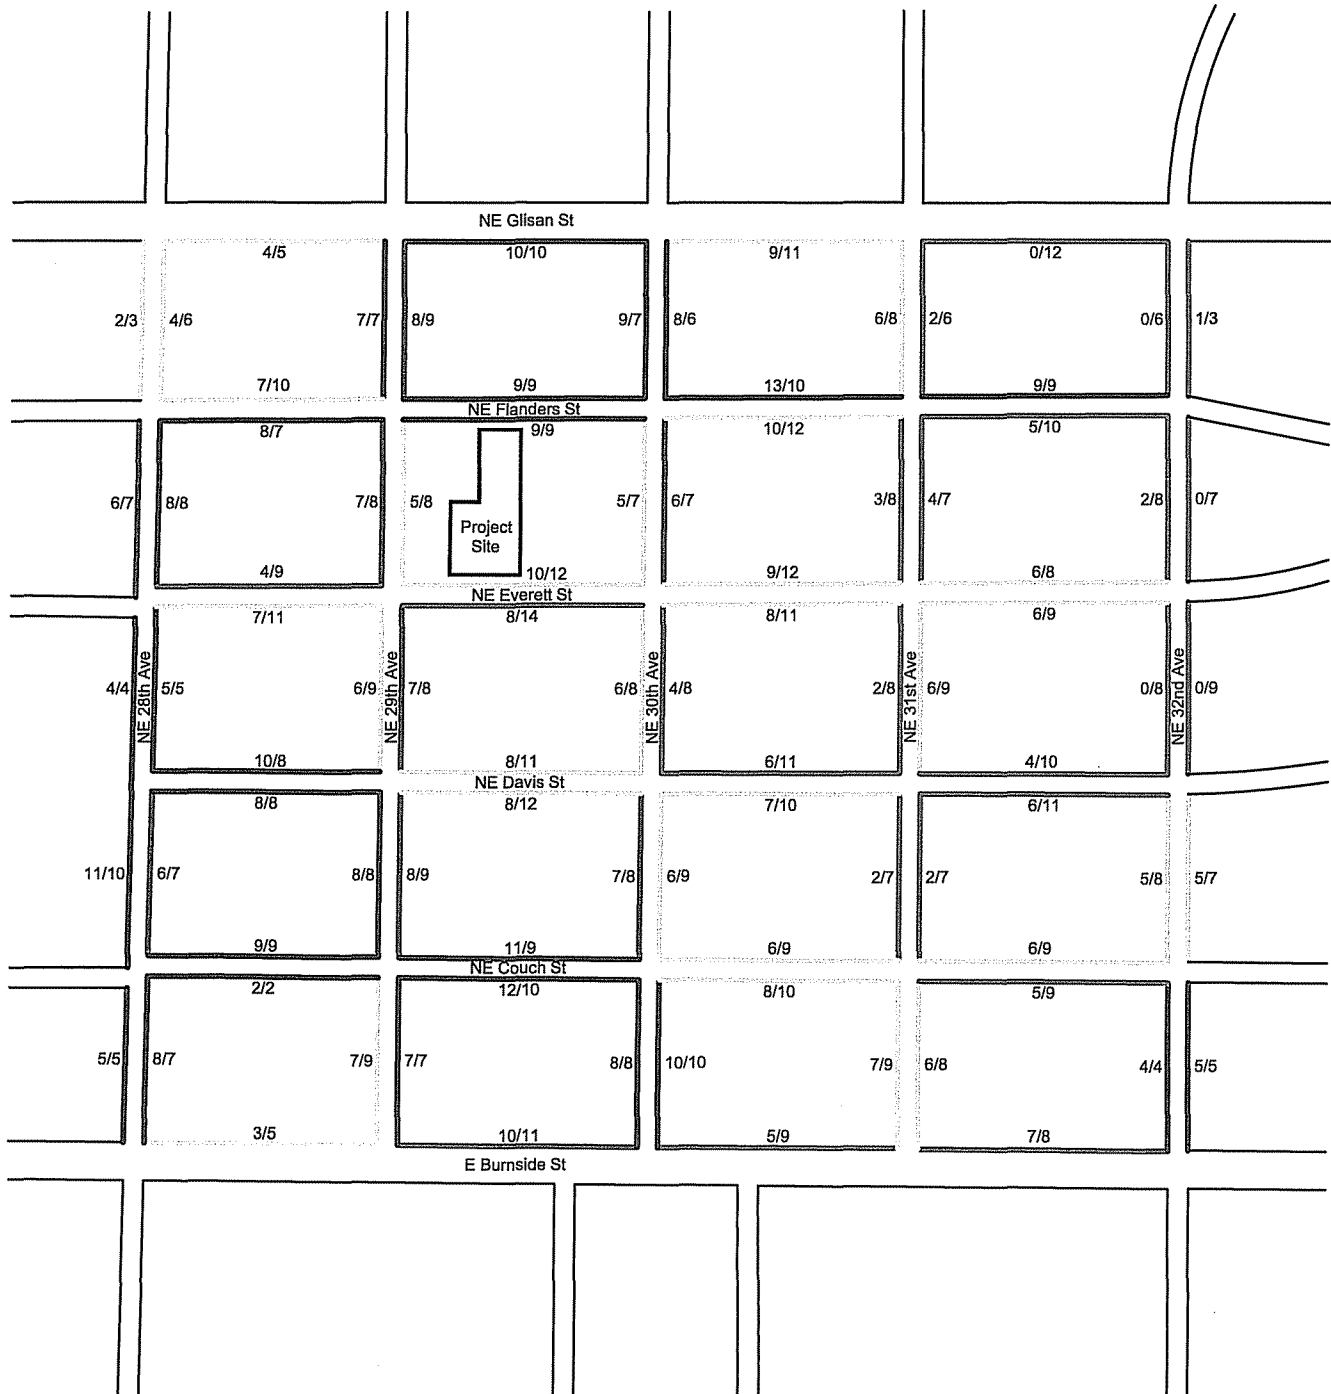
FIGURE
8

X/Y = "X" OCCUPIED / "Y" AVAILABLE ON-STREET SPACES
 TOTAL OBSERVED PARKING DEMAND = 74% OF CAPACITY

PARKING OCCUPANCY MAP
 Everett House Community Healing Center
 6:00 PM -7:00 PM (Saturday, December 9, 2017)

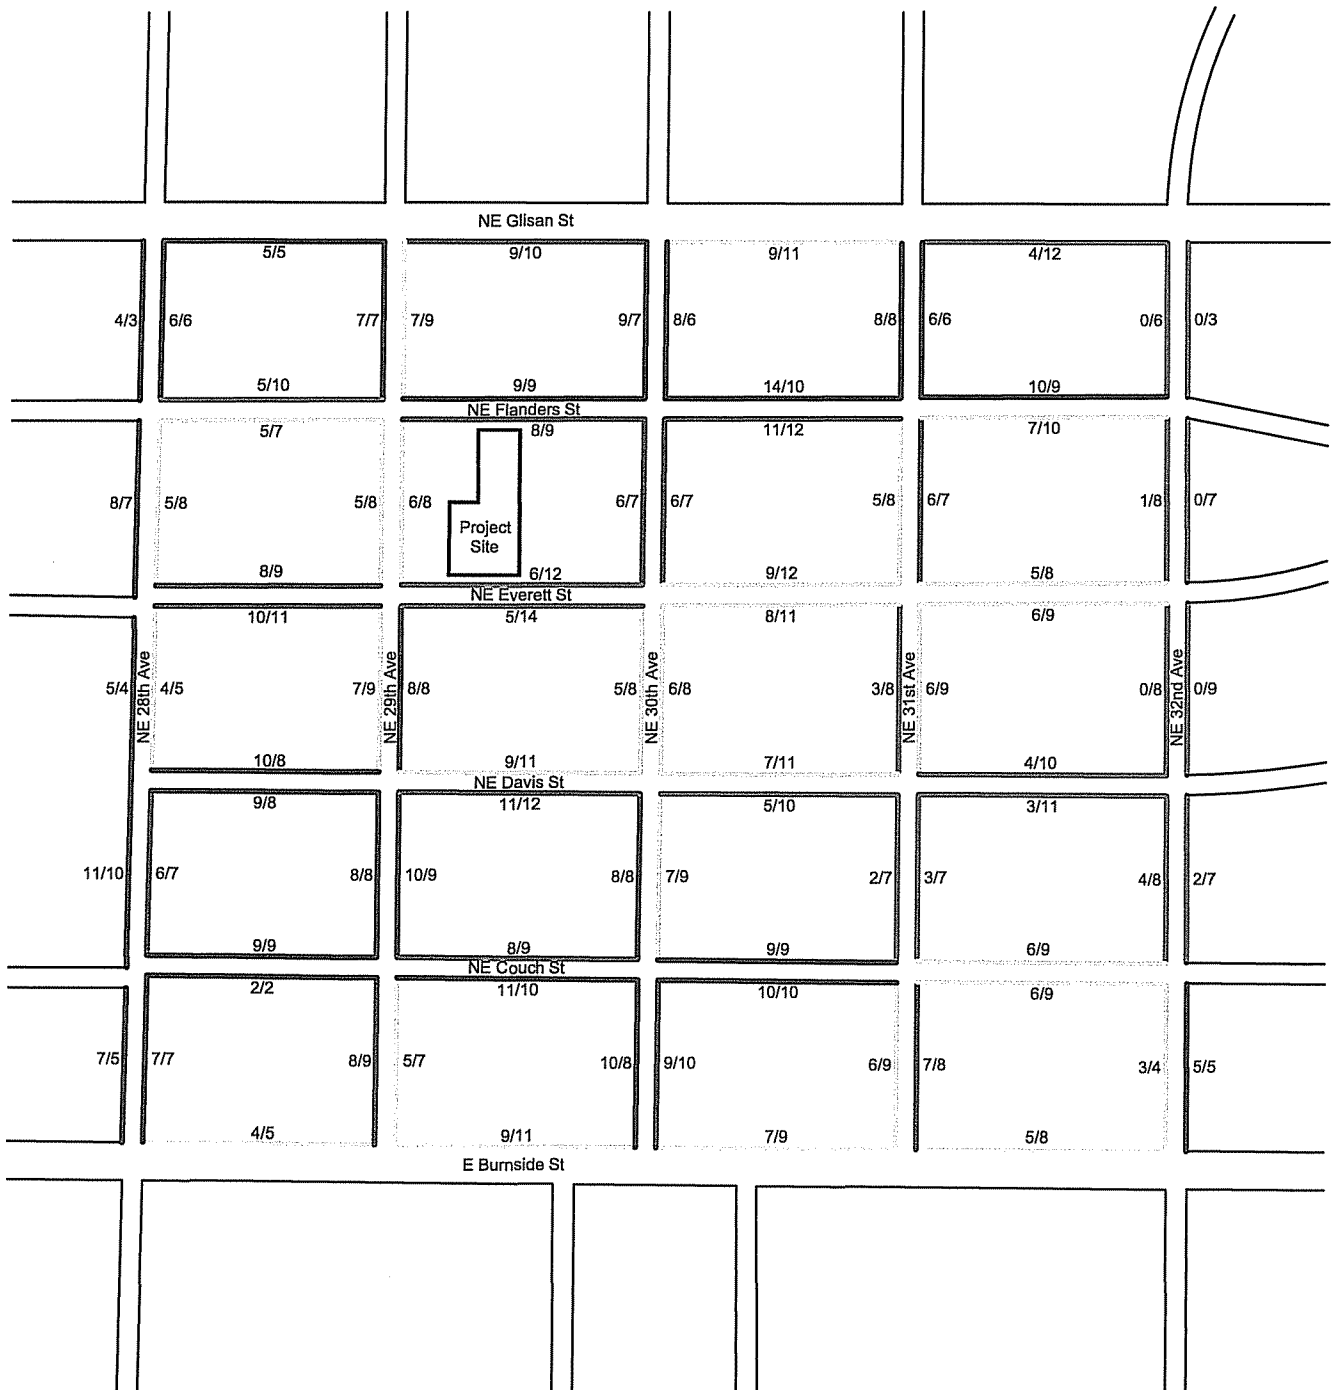
FIGURE
 10

X/Y = "X" OCCUPIED / "Y" AVAILABLE ON-STREET SPACES
 TOTAL OBSERVED PARKING DEMAND = 77% OF CAPACITY

PARKING OCCUPANCY MAP
 Everett House Community Healing Center
 8:00 PM - 9:00 PM (Saturday, December 9, 2017)

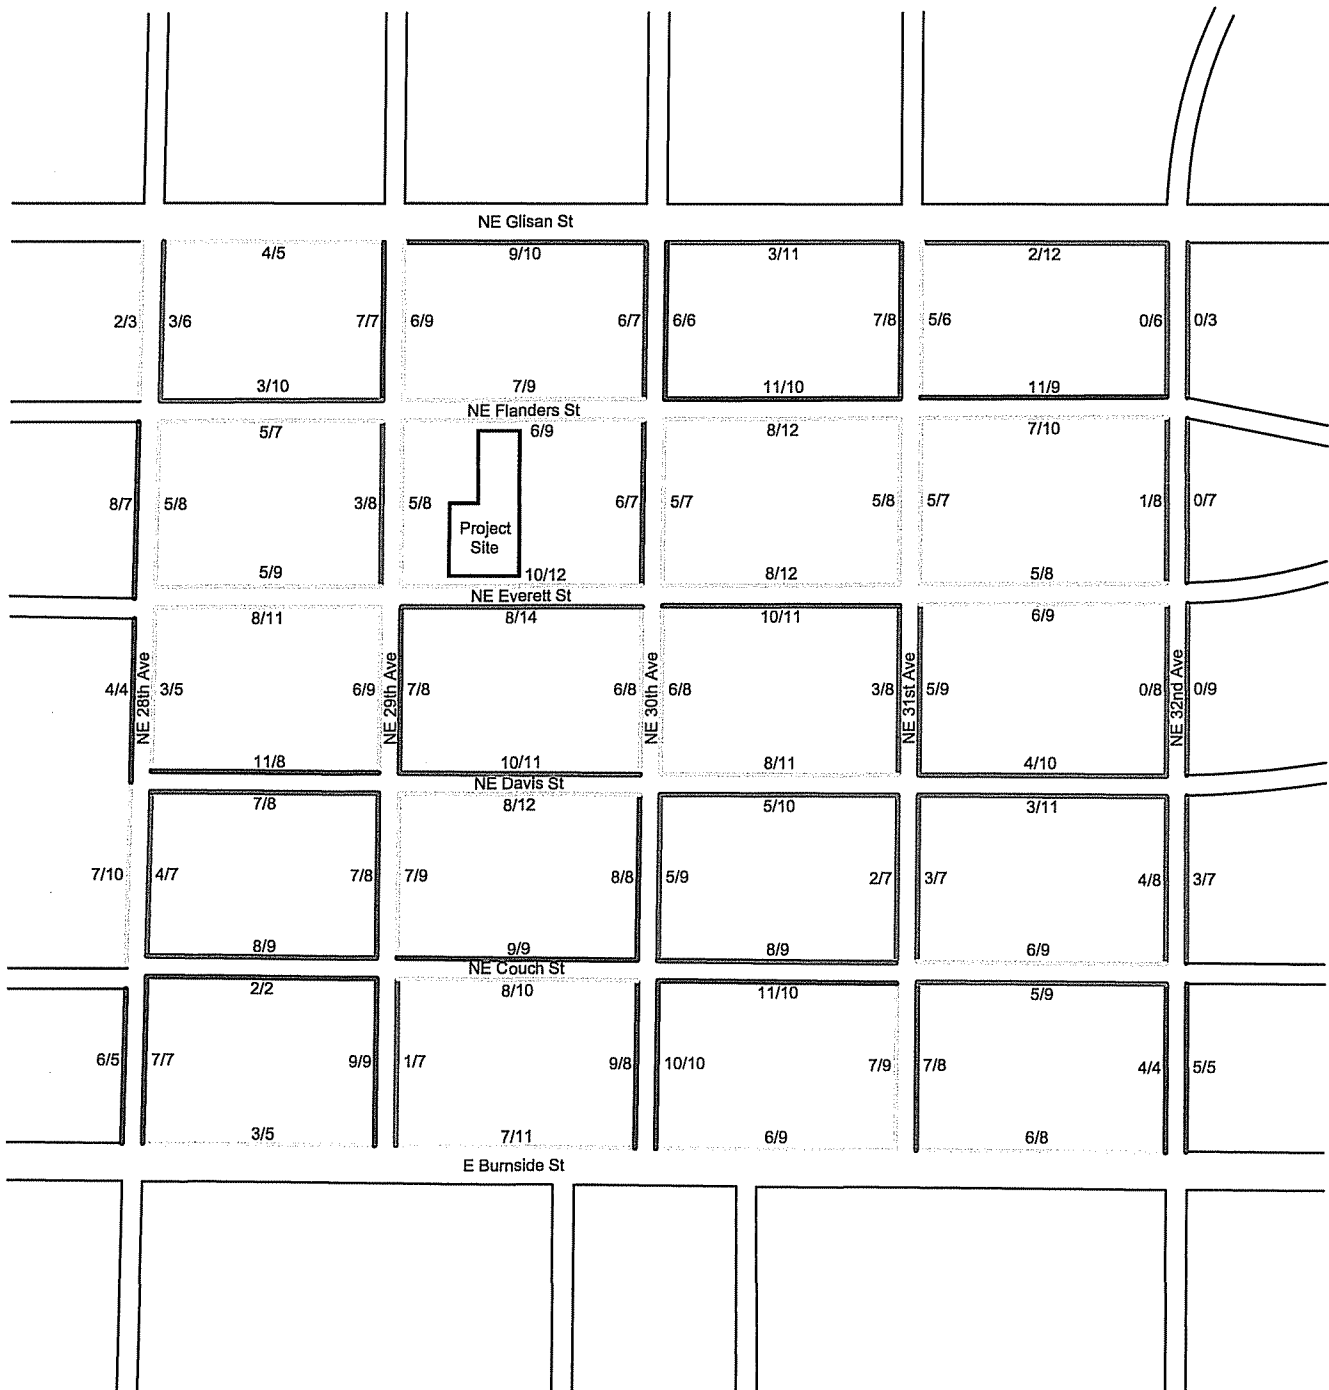
FIGURE
11

X/Y = "X" OCCUPIED / "Y" AVAILABLE ON-STREET SPACES
 TOTAL OBSERVED PARKING DEMAND = 69% OF CAPACITY

PARKING OCCUPANCY MAP
 Everett House Community Healing Center
 9:00 PM - 10:00 PM (Saturday, December 9, 2017)

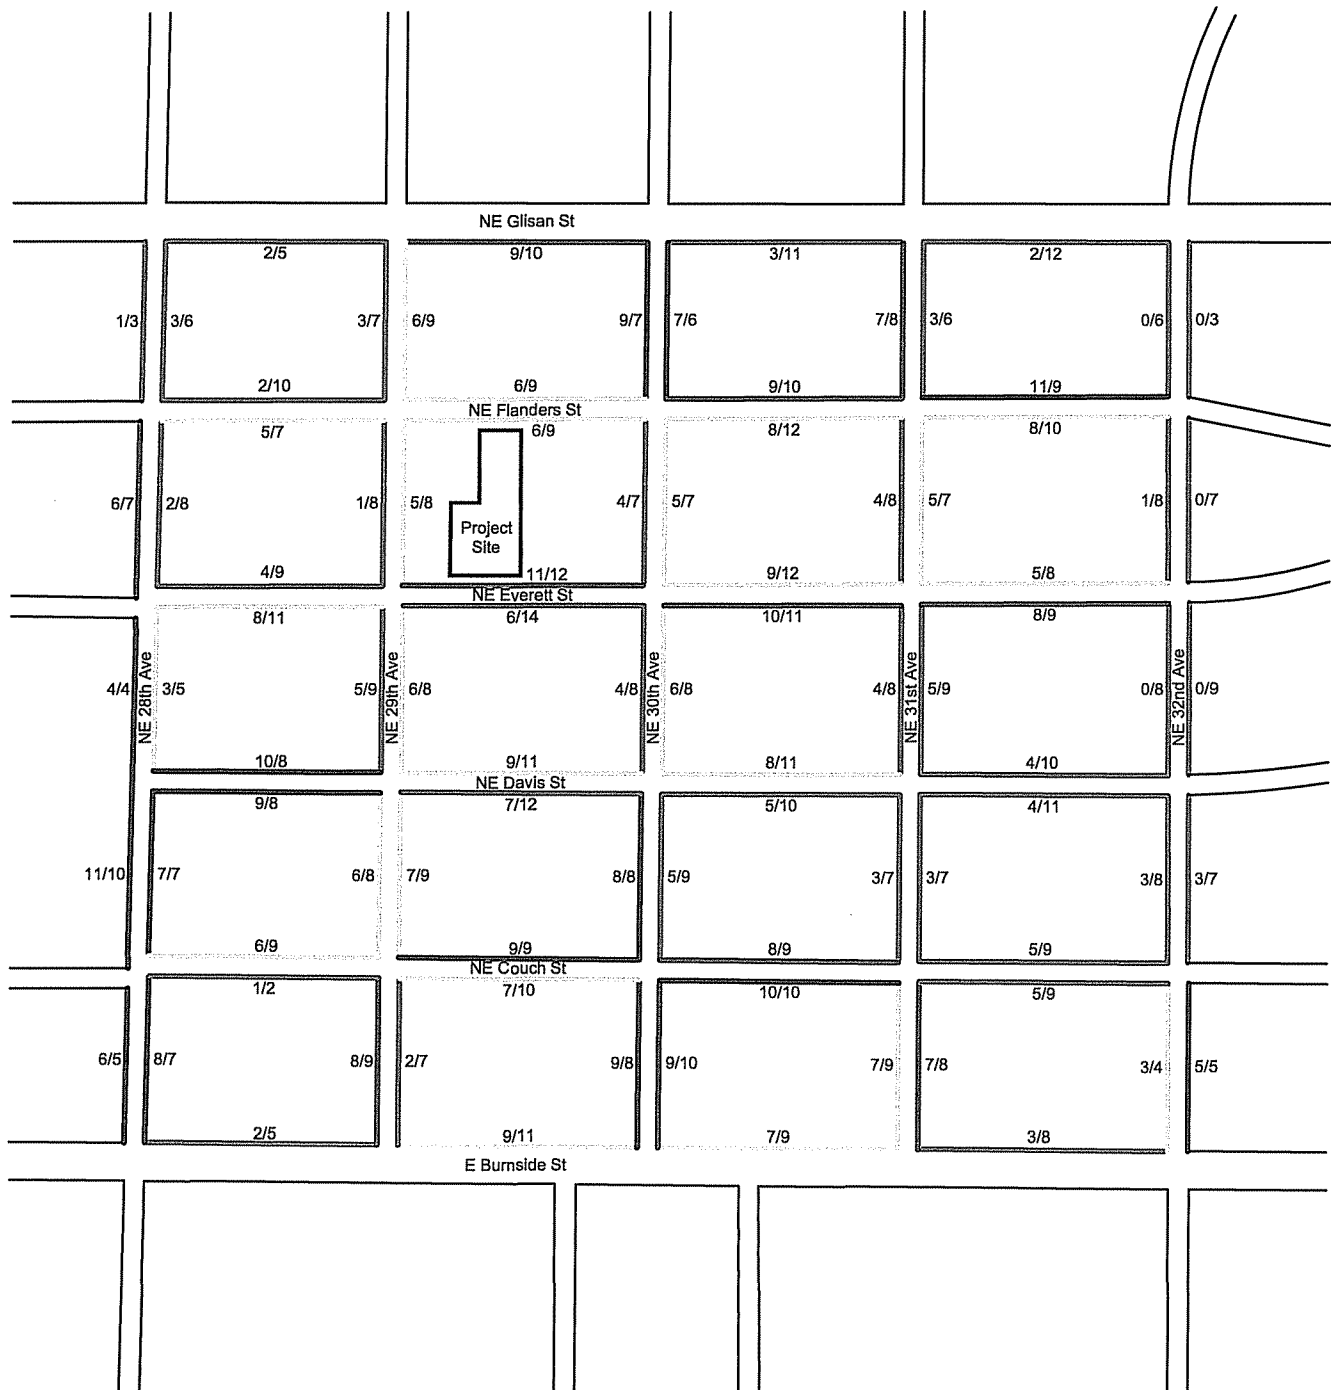
FIGURE
12

X/Y = "X" OCCUPIED / "Y" AVAILABLE ON-STREET SPACES
 TOTAL OBSERVED PARKING DEMAND = 66% OF CAPACITY

PARKING OCCUPANCY MAP
 Everett House Community Healing Center
 10:00 PM - 11:00 PM (Saturday, December 9, 2017)

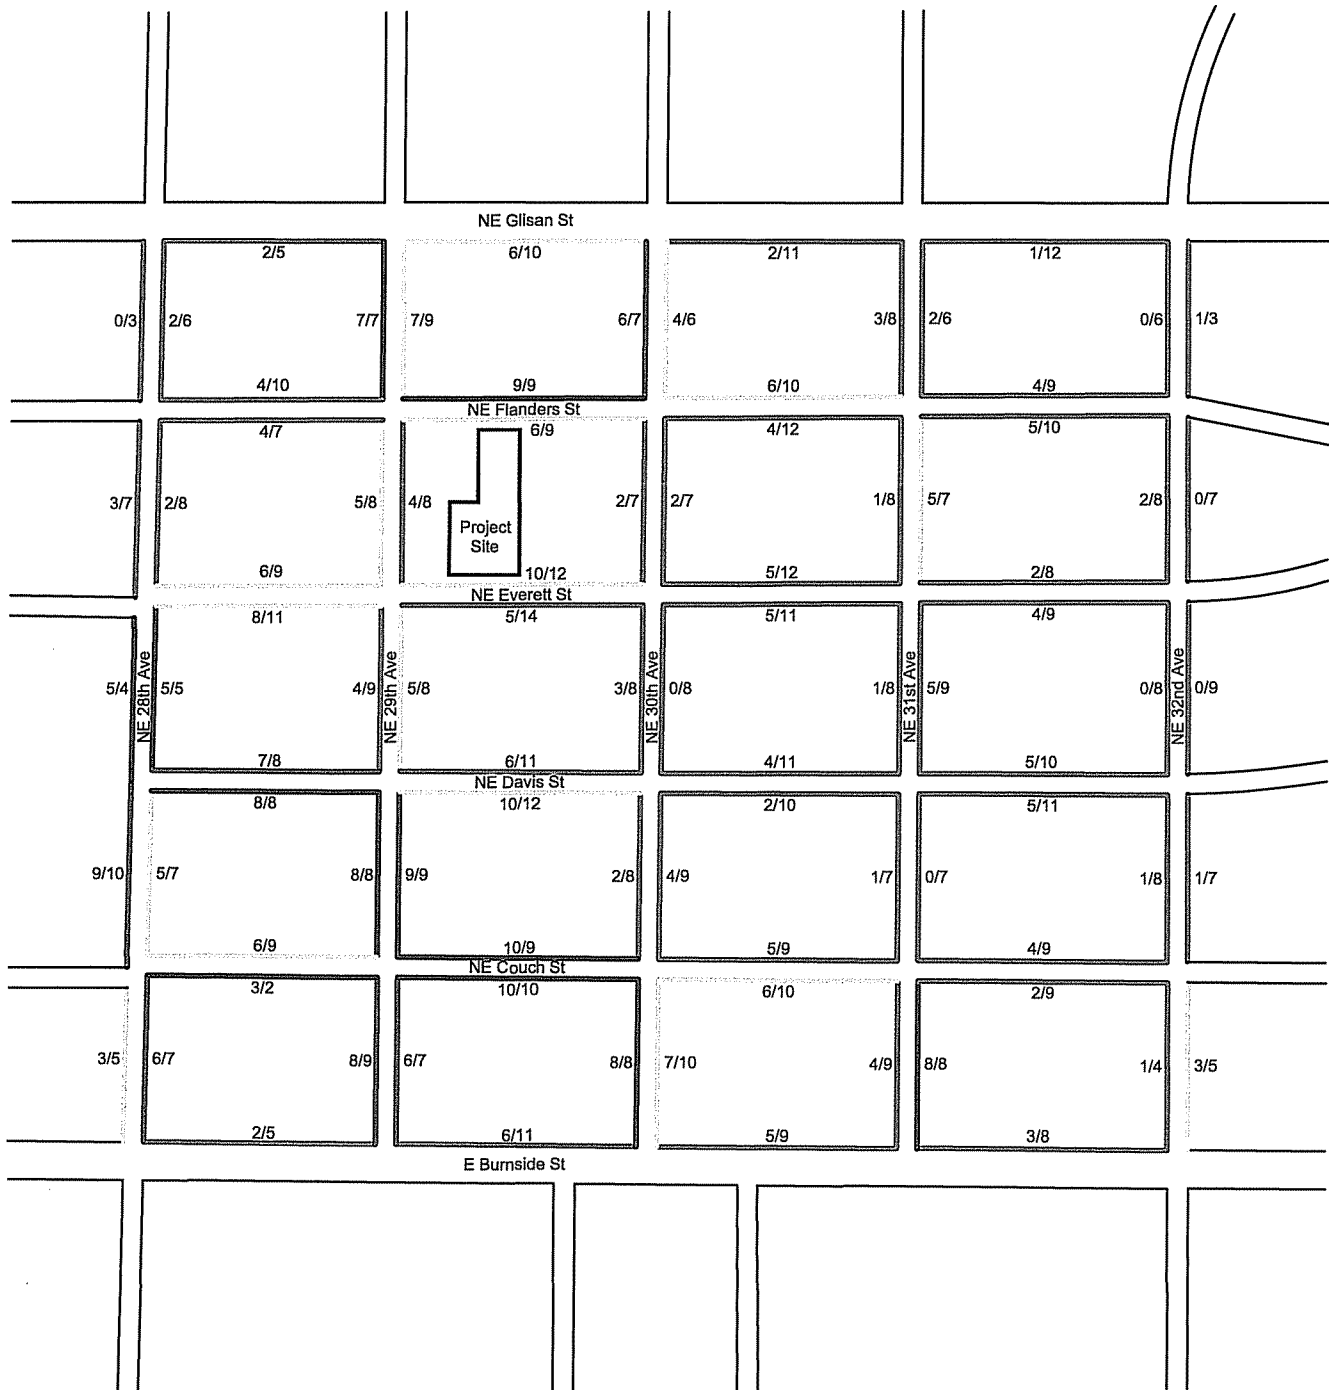
FIGURE
13

X/Y = "X" OCCUPIED / "Y" AVAILABLE ON-STREET SPACES
 TOTAL OBSERVED PARKING DEMAND = 52% OF CAPACITY

PARKING OCCUPANCY MAP
 Everett House Community Healing Center
 11:00 AM - 12:00 PM (Tuesday, December 12, 2017)
