RE: Everett House Community Healing Center – Transportation Analysis Letter

We have completed our transportation analysis of your existing conditional use facility at 2917 and 2927 SE Everett Street and 2926 NE Flanders Street in Portland, Oregon. The subject site is the Everett House Community Healing Center, which comprises the three adjacent tax lots and provides community healing and social services in education and wellness programs including services such as healing workshops, neighbors in need programs, teahouse social, relaxation, massage, acupuncture, new thought discussion programs, counselling, domestic violence victims' resources, yoga, chiropractic wellness, spa, and other forms of relaxation and more.

Everett House Community Healing Center

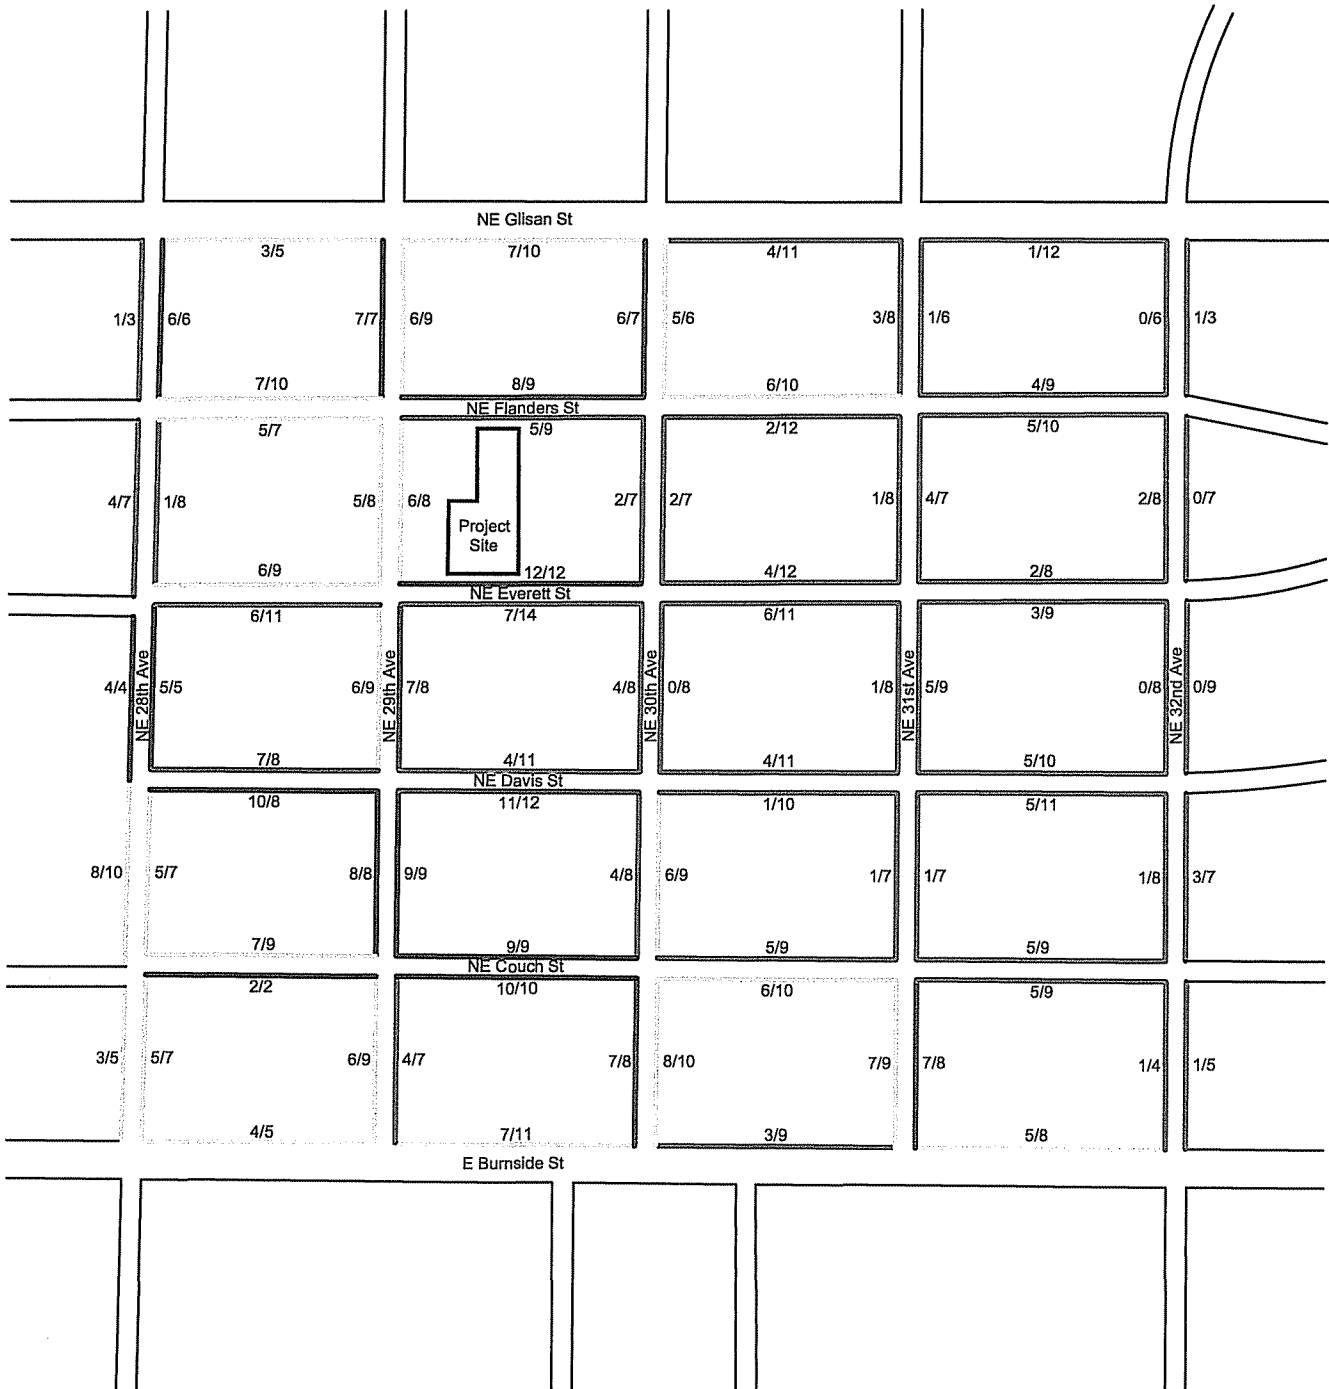
FIGURE
14

X/Y = "X" OCCUPIED / "Y" AVAILABLE ON-STREET SPACES
 TOTAL OBSERVED PARKING DEMAND = 55% OF CAPACITY

PARKING OCCUPANCY MAP
 Everett House Community Healing Center
 12:00 PM - 1:00 PM (Tuesday, December 12, 2017)

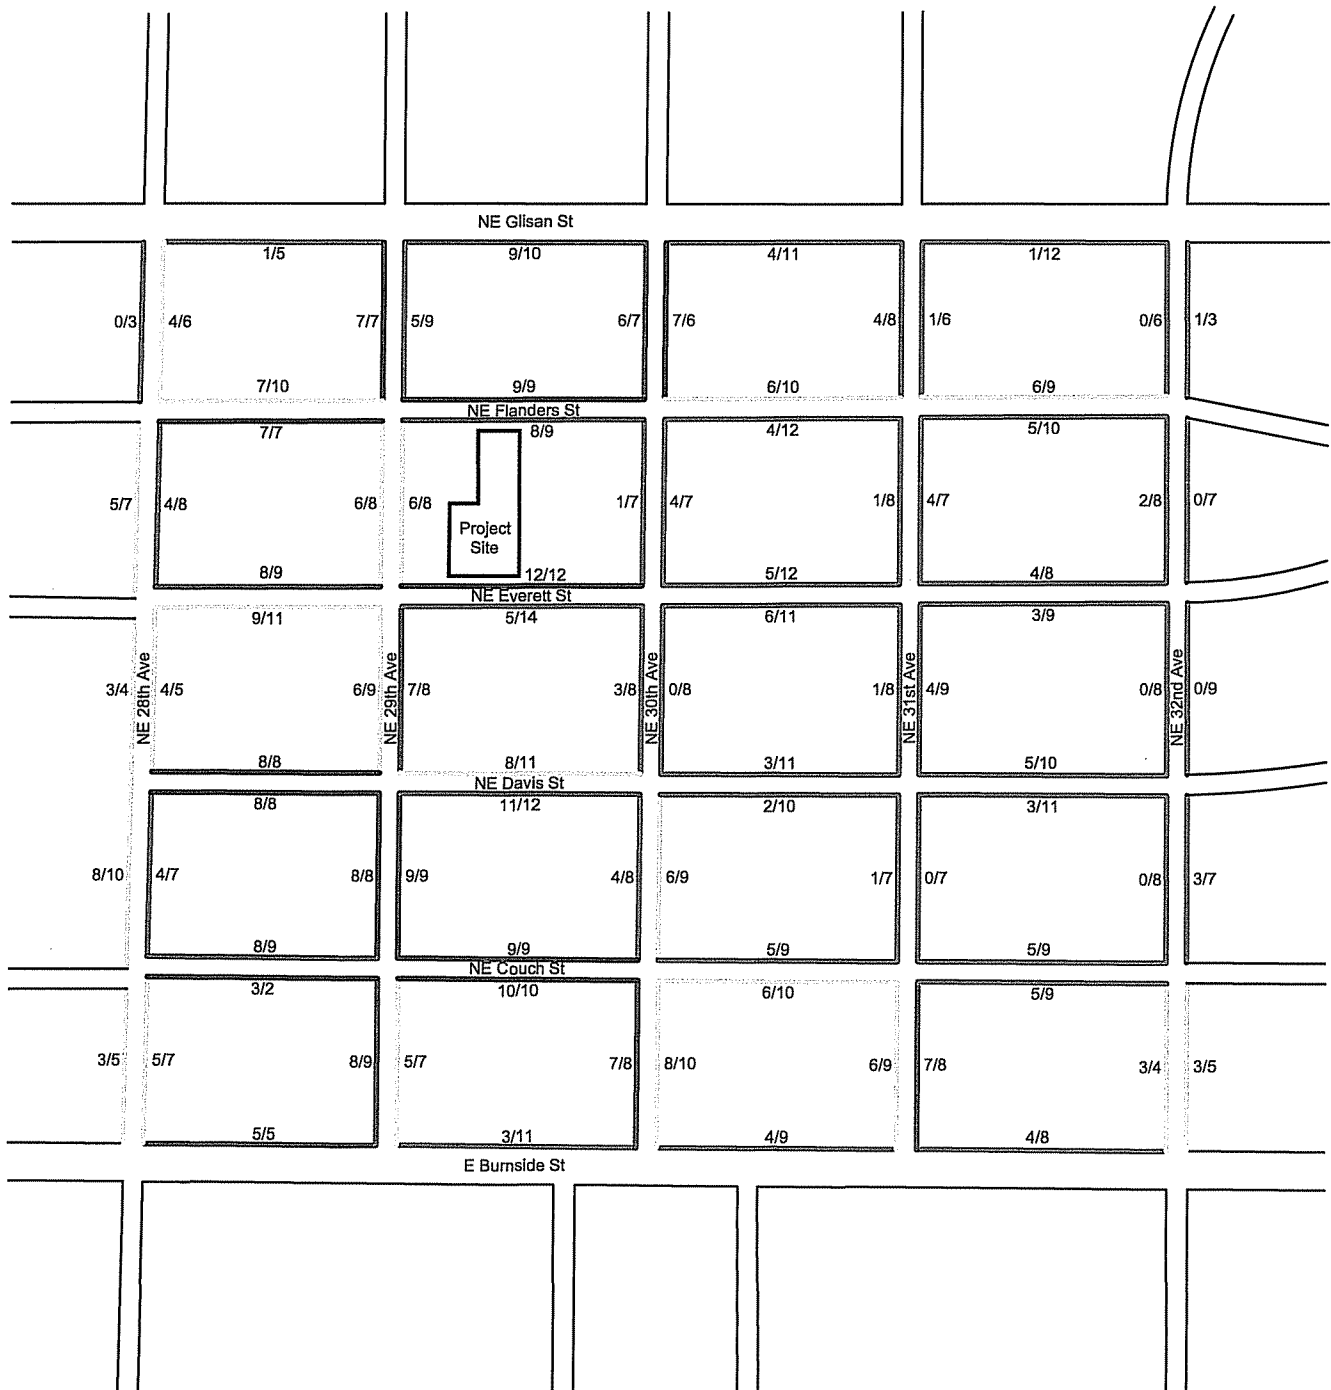
FIGURE
15

X/Y = "X" OCCUPIED / "Y" AVAILABLE ON-STREET SPACES
 TOTAL OBSERVED PARKING DEMAND = 58% OF CAPACITY

PARKING OCCUPANCY MAP
 Everett House Community Healing Center
 1:00 PM - 2:00 PM (Tuesday, December 12, 2017)

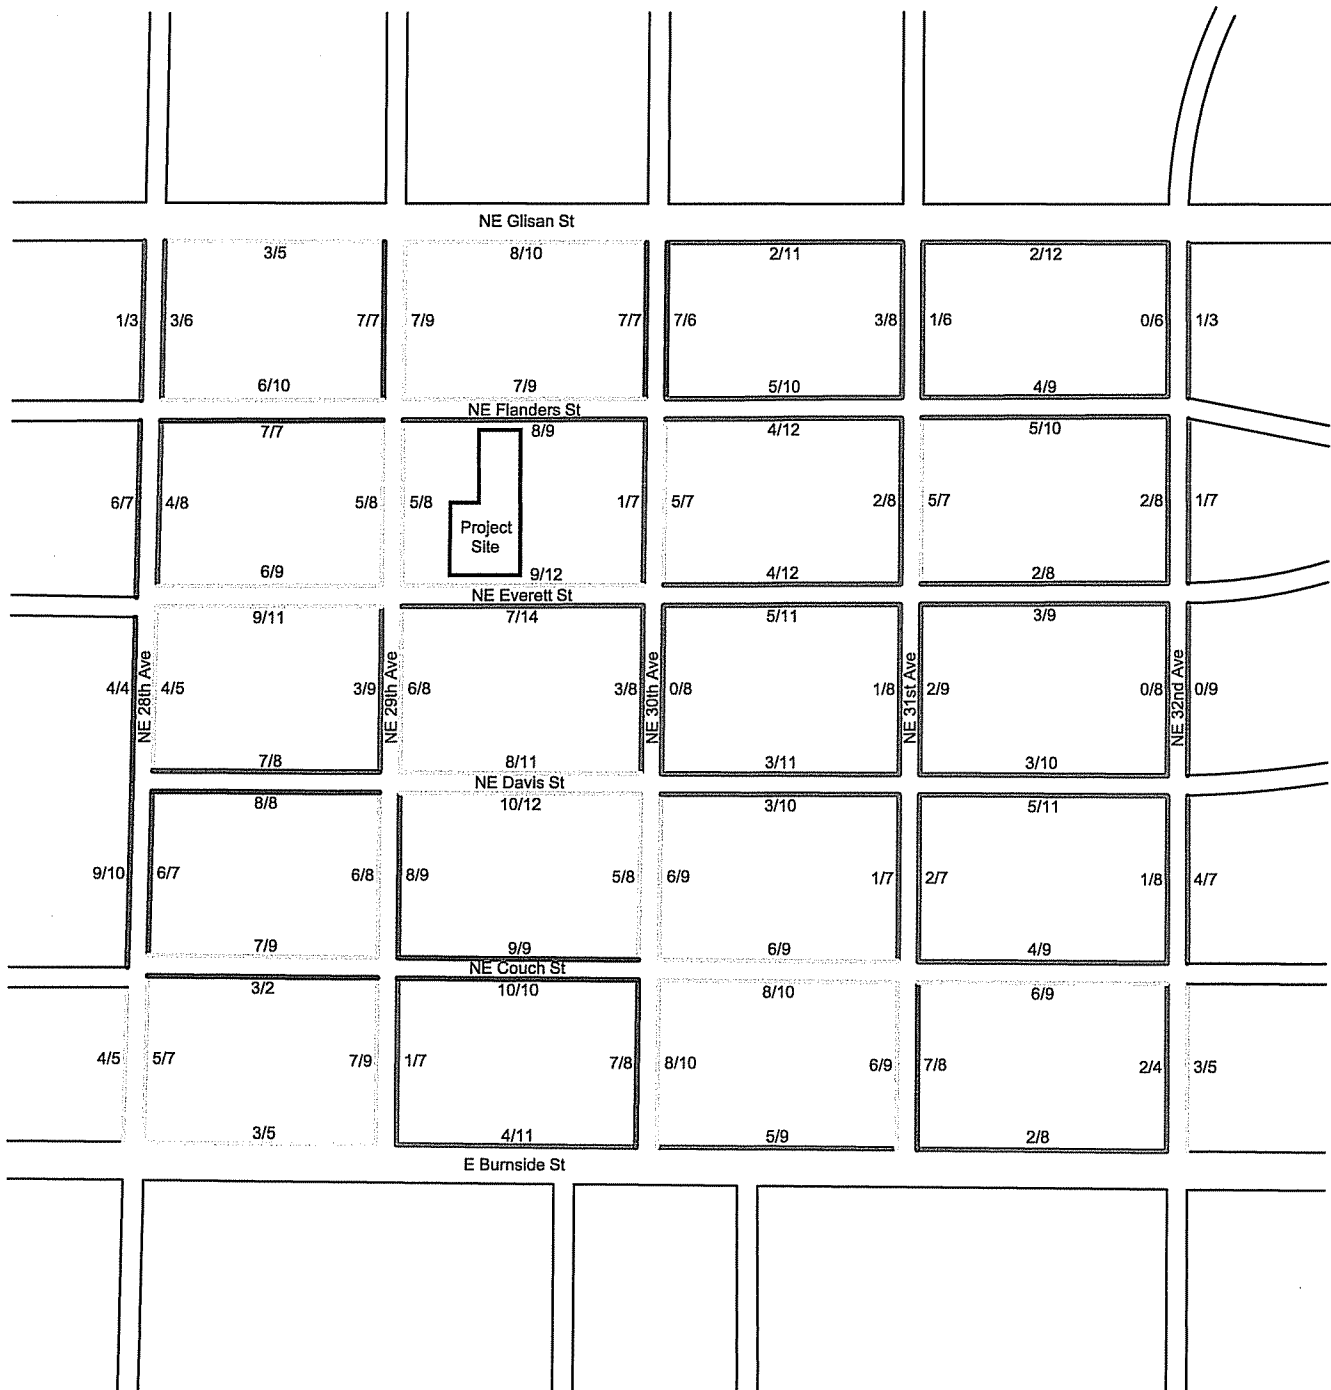
FIGURE
16

X/Y = "X" OCCUPIED / "Y" AVAILABLE ON-STREET SPACES
 TOTAL OBSERVED PARKING DEMAND = 56% OF CAPACITY

PARKING OCCUPANCY MAP
 Everett House Community Healing Center
 2:00 PM - 3:00 PM (Tuesday, December 12, 2017)

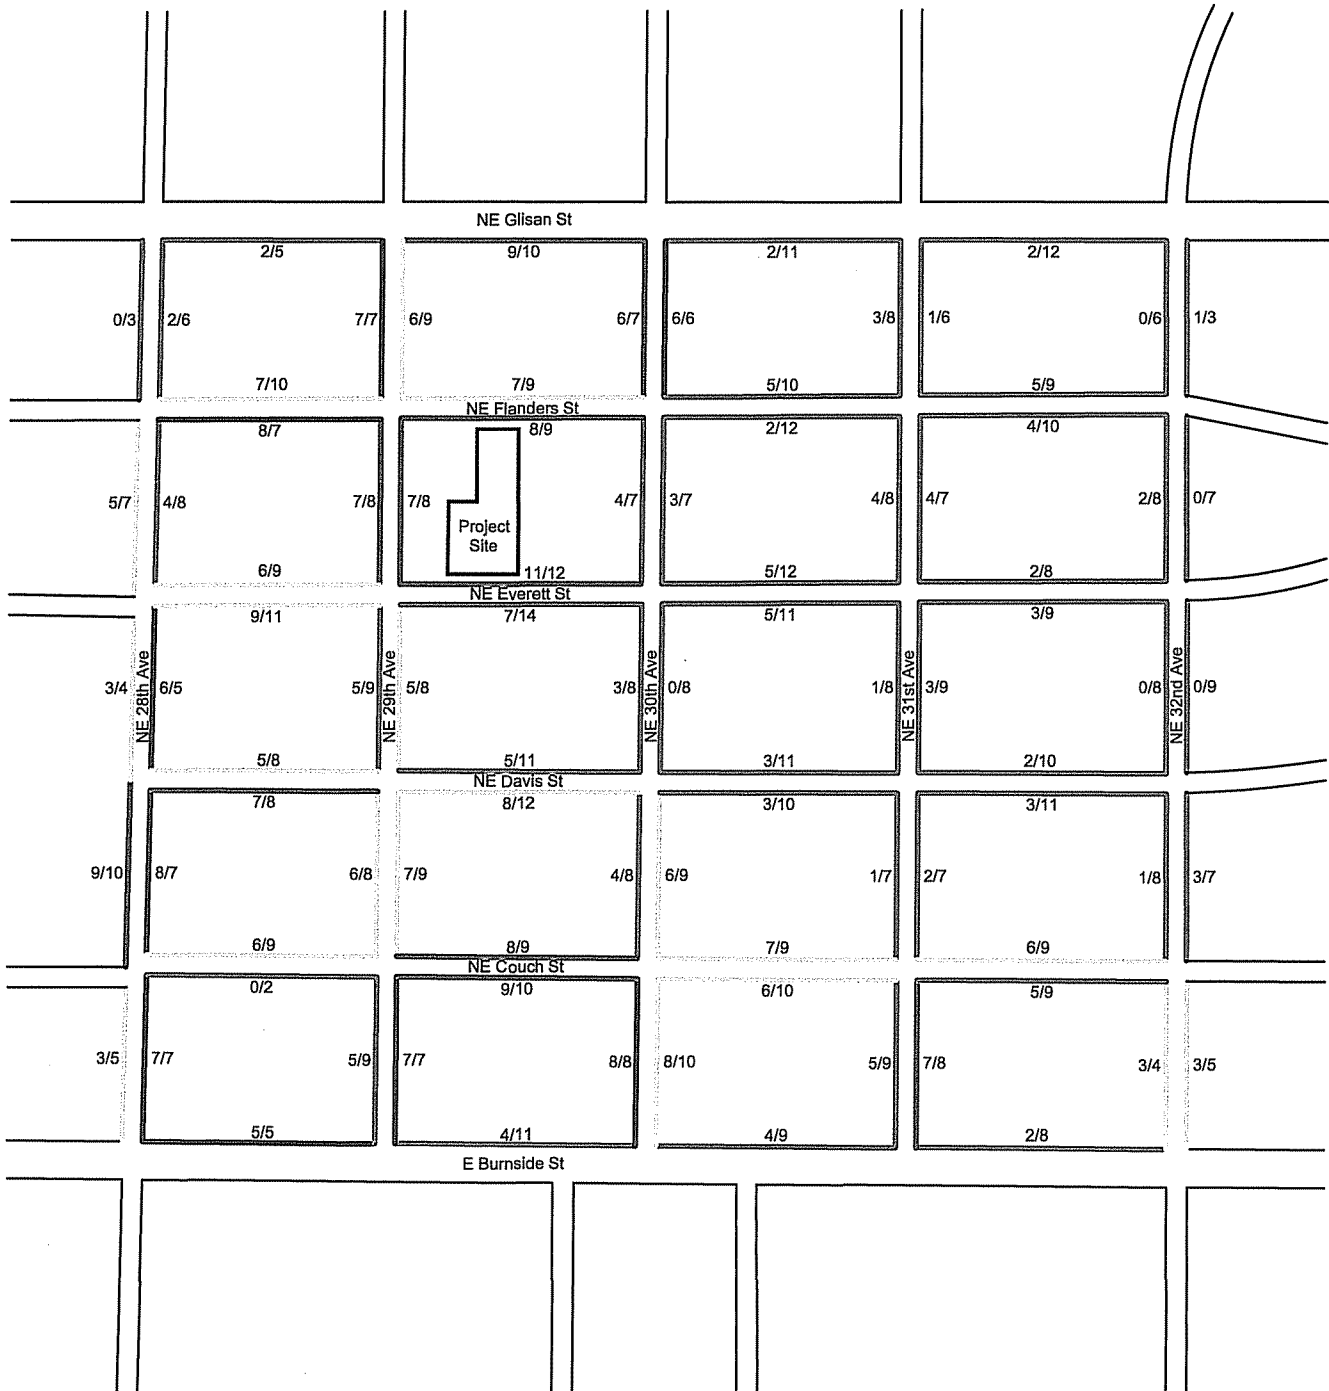
FIGURE
 17

X/Y = "X" OCCUPIED / "Y" AVAILABLE ON-STREET SPACES
 TOTAL OBSERVED PARKING DEMAND = 55% OF CAPACITY

PARKING OCCUPANCY MAP
 Everett House Community Healing Center
 3:00 PM - 4:00 PM (Tuesday, December 12, 2017)

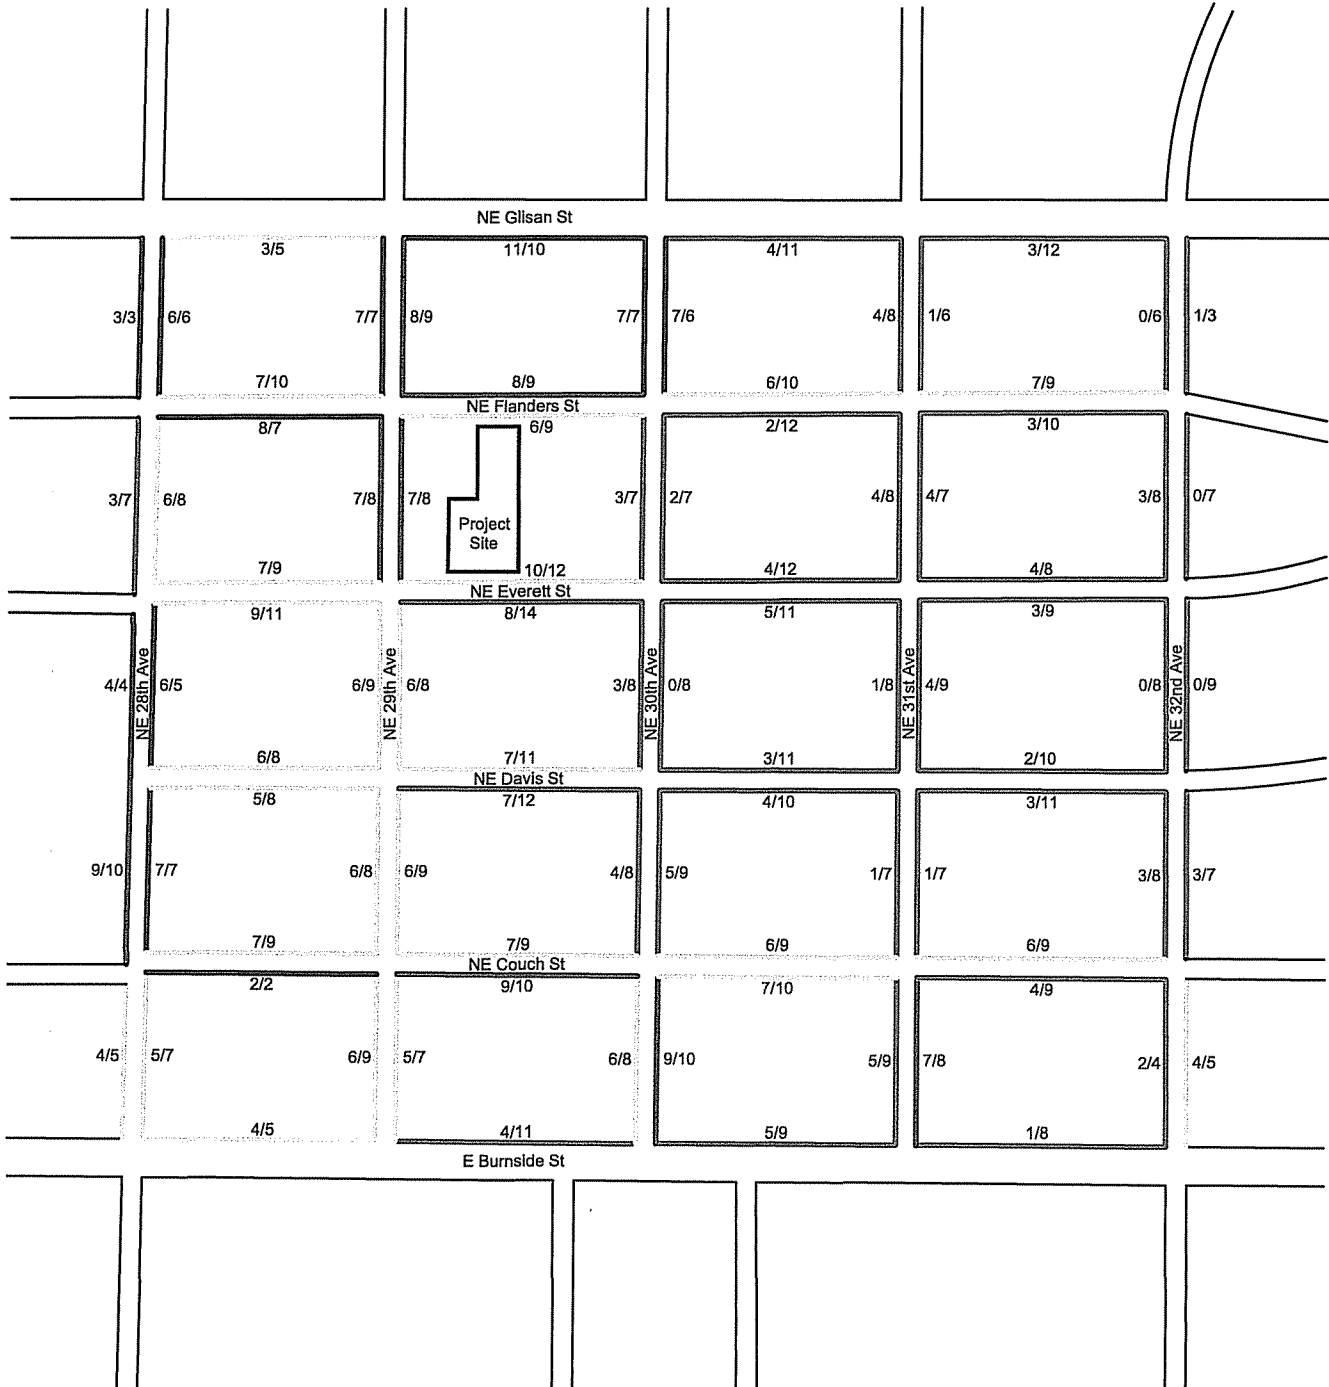
FIGURE
 18

X/Y = "X" OCCUPIED / "Y" AVAILABLE ON-STREET SPACES
 TOTAL OBSERVED PARKING DEMAND = 58% OF CAPACITY

PARKING OCCUPANCY MAP
 Everett House Community Healing Center
 4:00 PM - 5:00 PM (Tuesday, December 12, 2017)

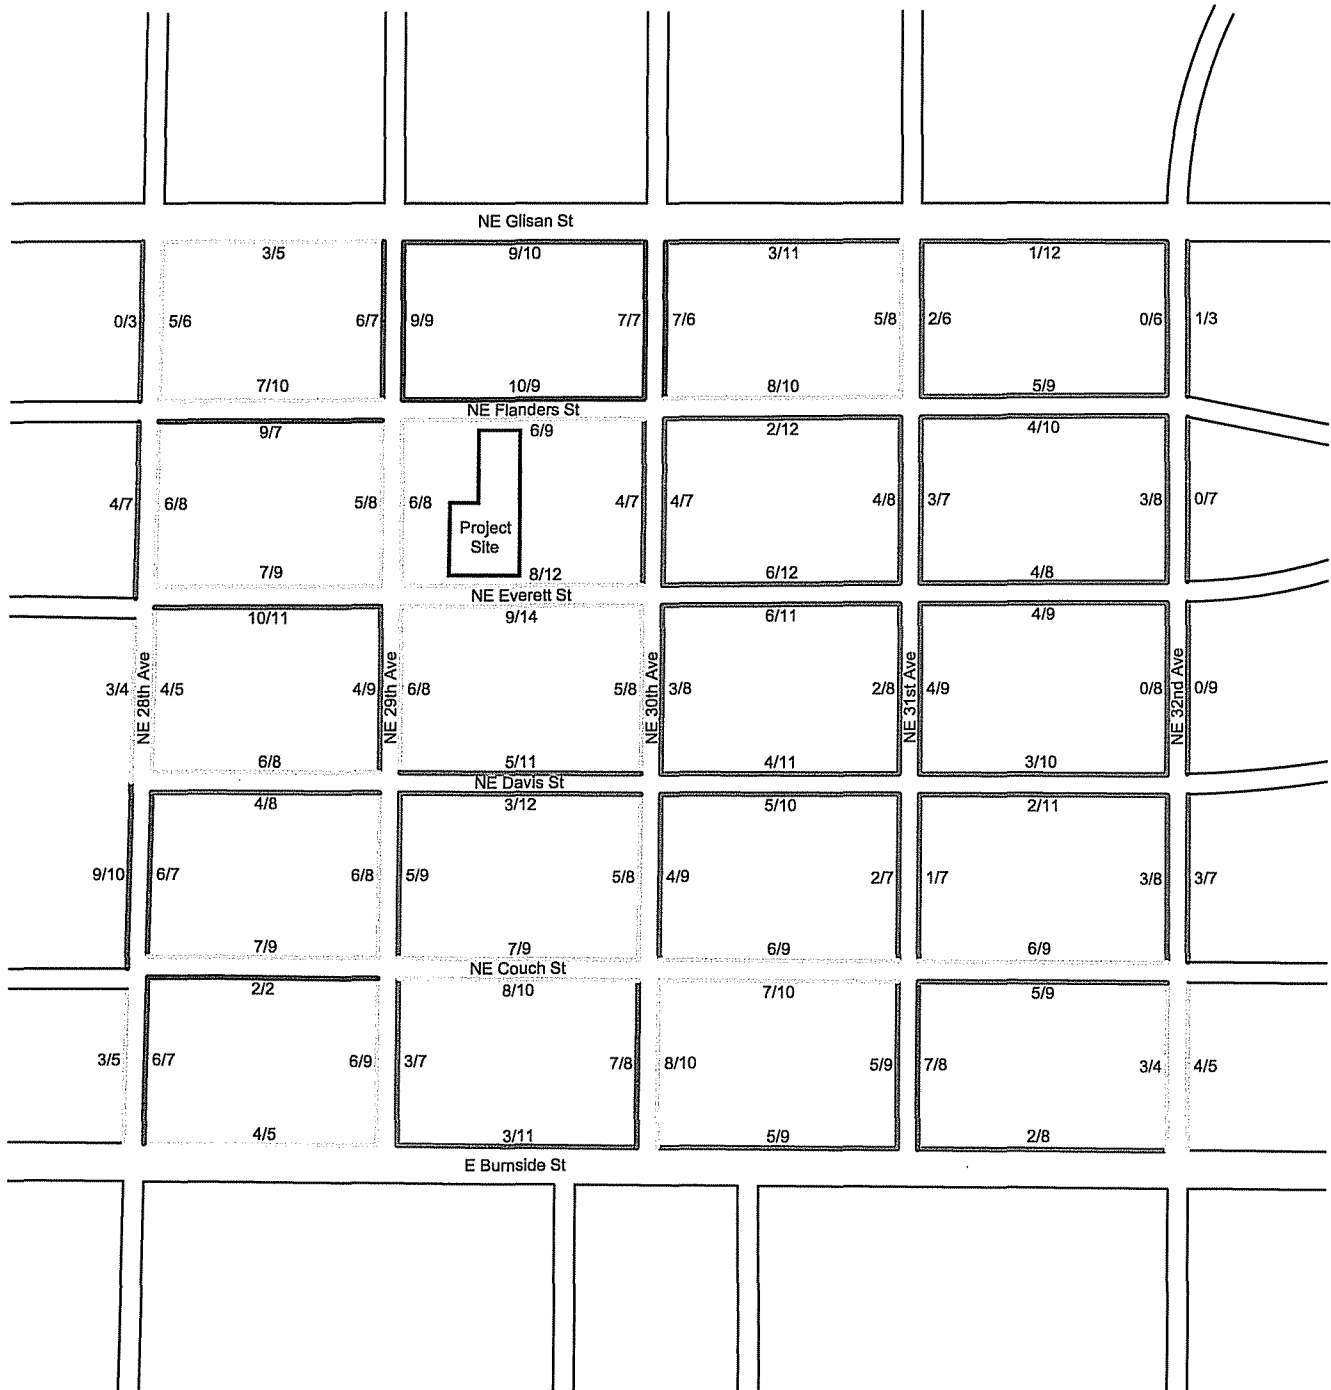
FIGURE
19

X/Y = "X" OCCUPIED / "Y" AVAILABLE ON-STREET SPACES
 TOTAL OBSERVED PARKING DEMAND = 57% OF CAPACITY

PARKING OCCUPANCY MAP
 Everett House Community Healing Center
 5:00 PM - 6:00 PM (Tuesday, December 12, 2017)

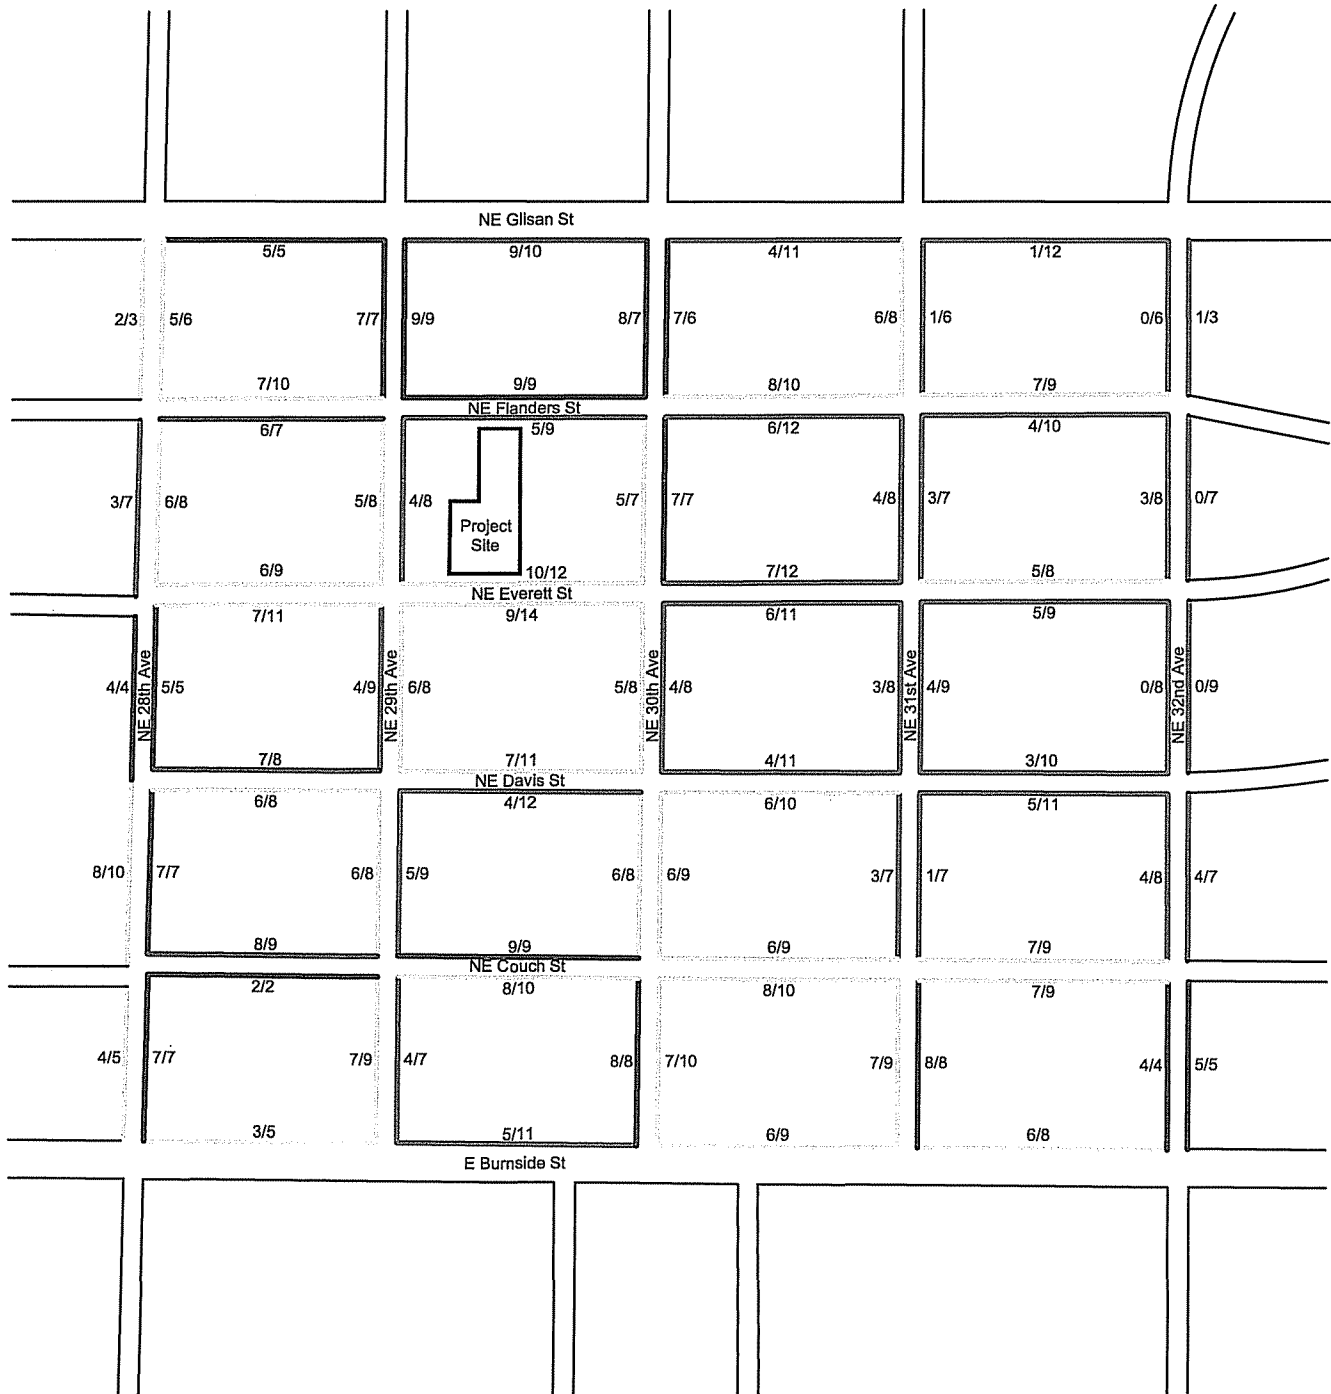
FIGURE
20

X/Y = "X" OCCUPIED / "Y" AVAILABLE ON-STREET SPACES
 TOTAL OBSERVED PARKING DEMAND = 64% OF CAPACITY

PARKING OCCUPANCY MAP
 Everett House Community Healing Center
 6:00 PM - 7:00 PM (Tuesday, December 12, 2017)

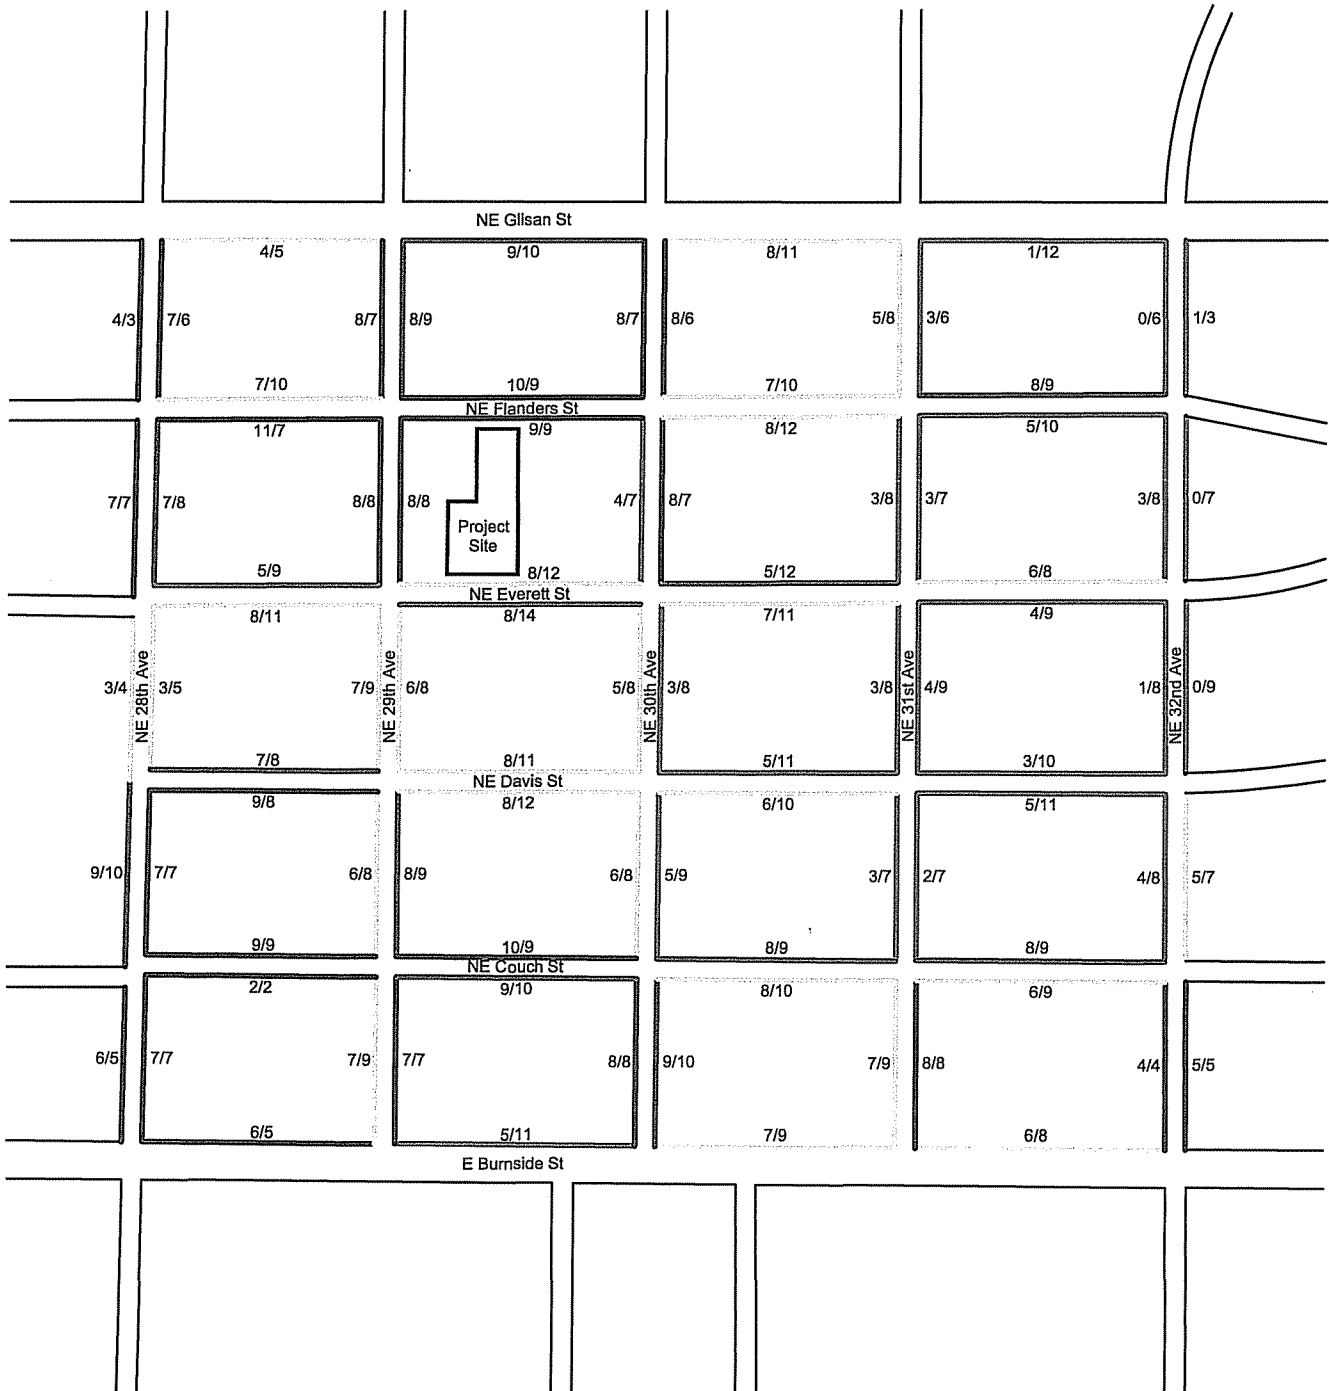
FIGURE
21

X/Y = "X" OCCUPIED / "Y" AVAILABLE ON-STREET SPACES
 TOTAL OBSERVED PARKING DEMAND = 72% OF CAPACITY

PARKING OCCUPANCY MAP
 Everett House Community Healing Center
 7:00 PM - 8:00 PM (Tuesday, December 12, 2017)

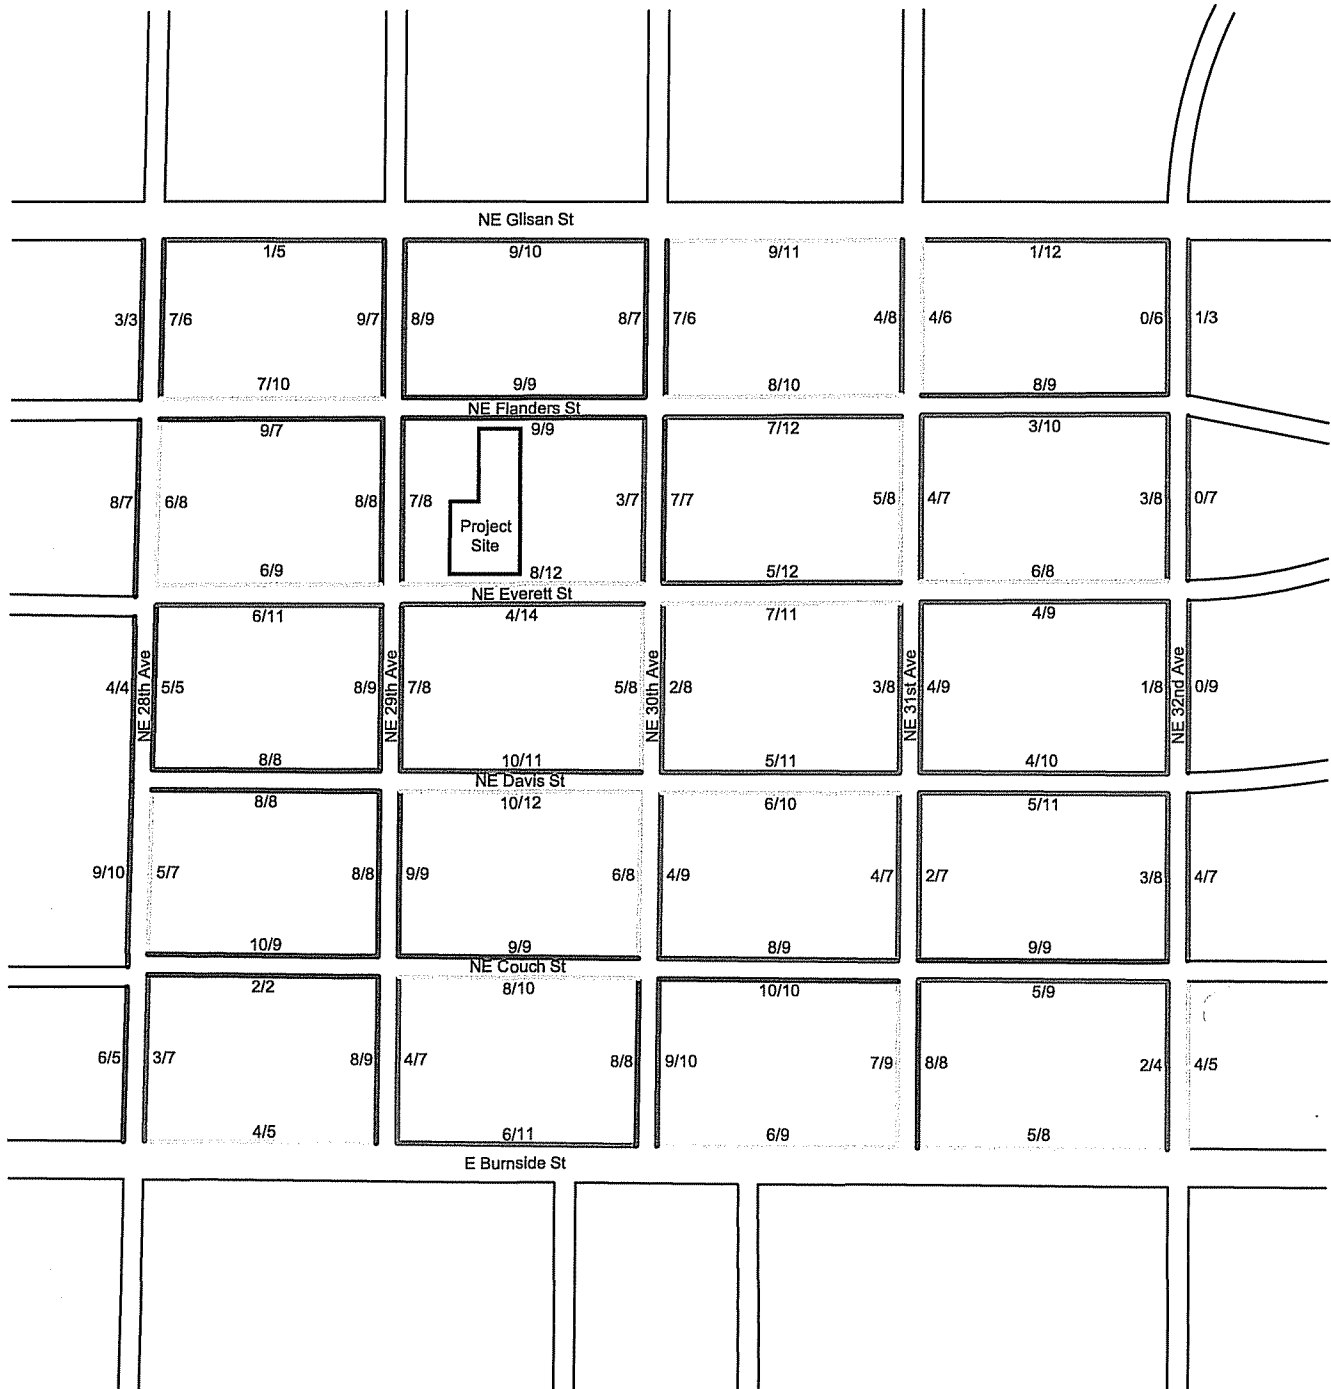
FIGURE
22

X/Y = "X" OCCUPIED / "Y" AVAILABLE ON-STREET SPACES
 TOTAL OBSERVED PARKING DEMAND = 70% OF CAPACITY

PARKING OCCUPANCY MAP
 Everett House Community Healing Center
 8:00 PM - 9:00 PM (Tuesday, December 12, 2017)

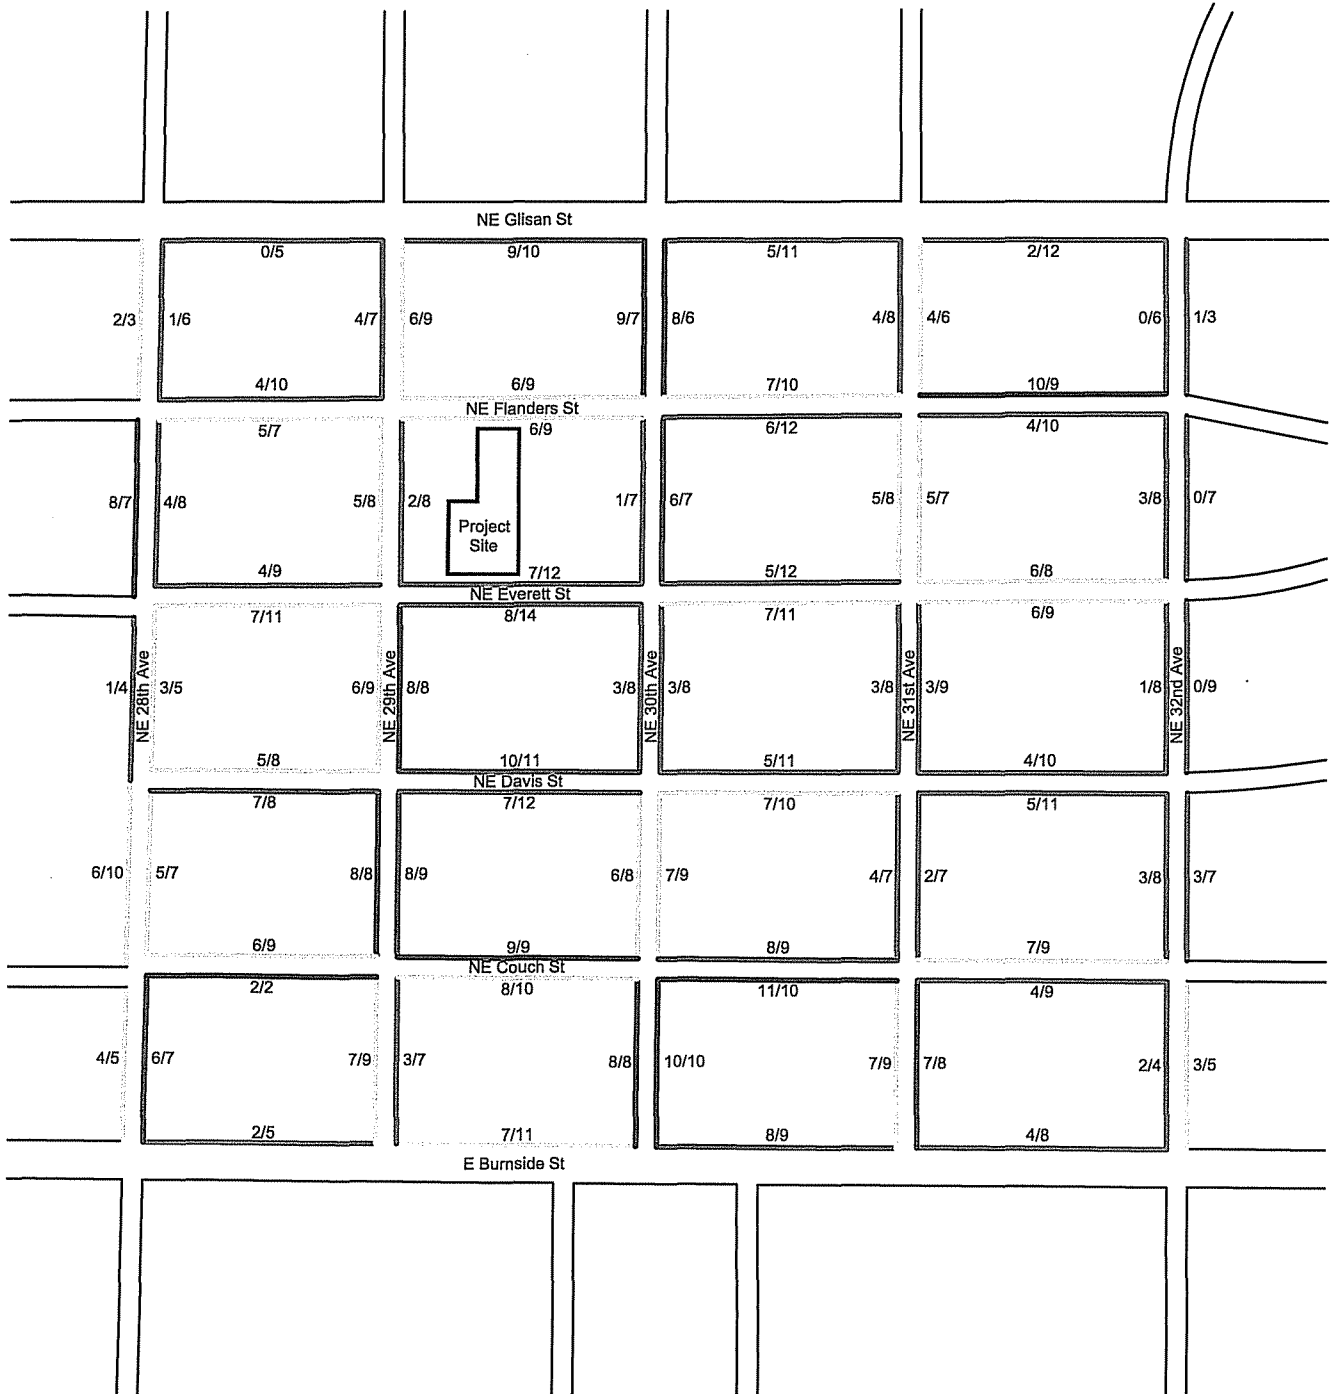
FIGURE
 23

X/Y = "X" OCCUPIED / "Y" AVAILABLE ON-STREET SPACES
 TOTAL OBSERVED PARKING DEMAND = 62% OF CAPACITY

PARKING OCCUPANCY MAP
 Everett House Community Healing Center
 9:00 PM - 10:00 PM (Tuesday, December 12, 2017)
